CONSTRUCTION EQUIPMENT

X59495 VOLVO EC300ELR 317492 - DIESEL ENGINE

Sample No: VCP437189
Oil Type: VOLVO ULTRA DIESEL ENGINE OIL 15W40 VDS-3
Job No: X59495

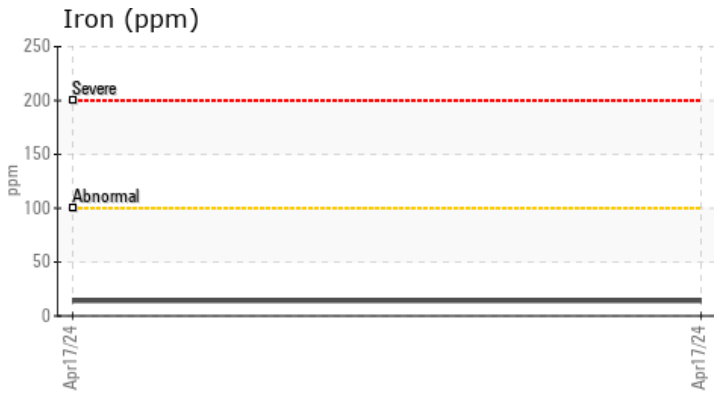
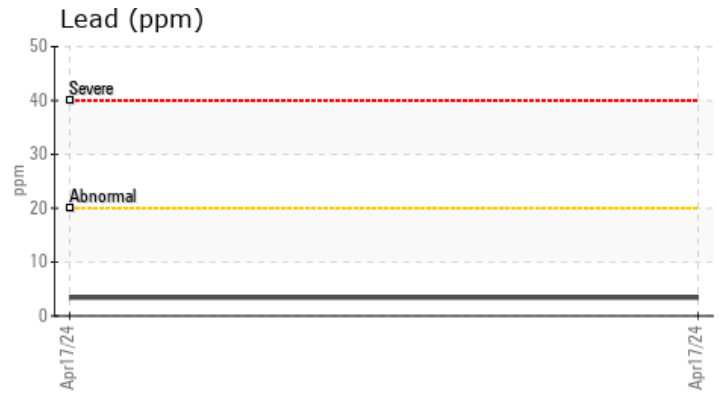
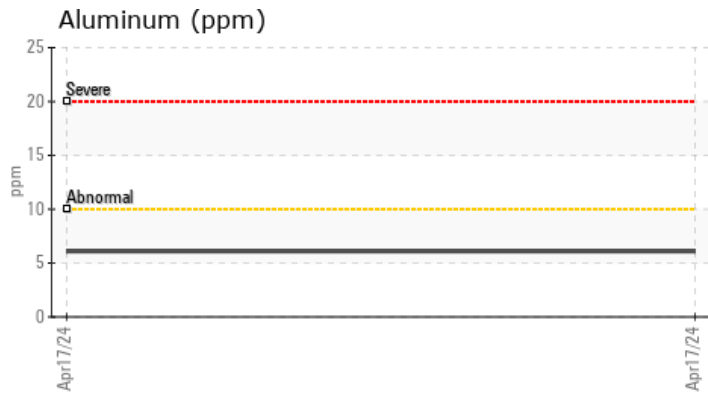
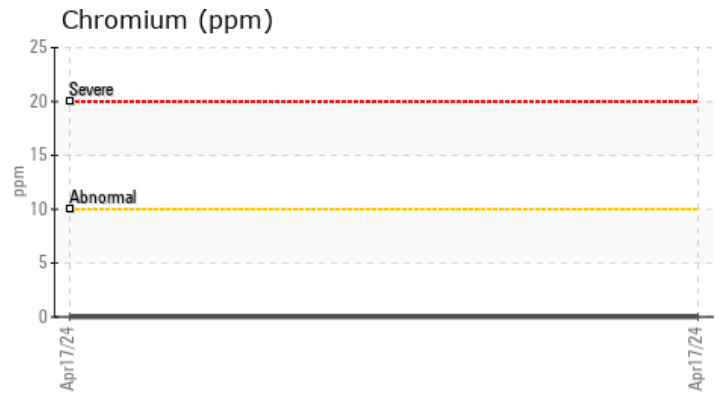
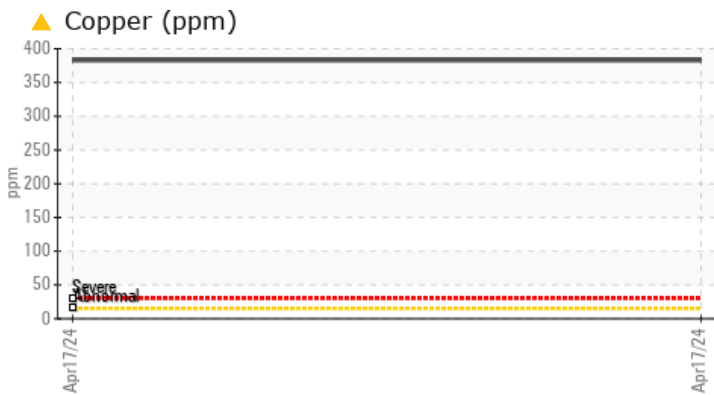
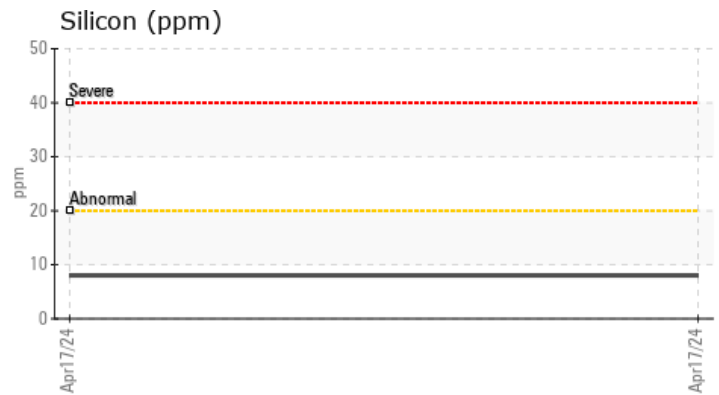
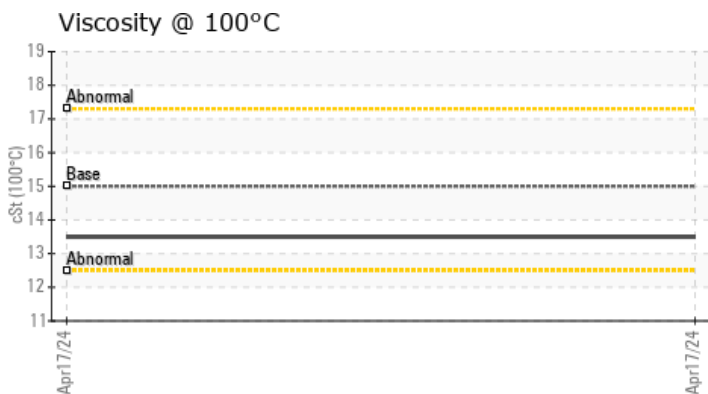
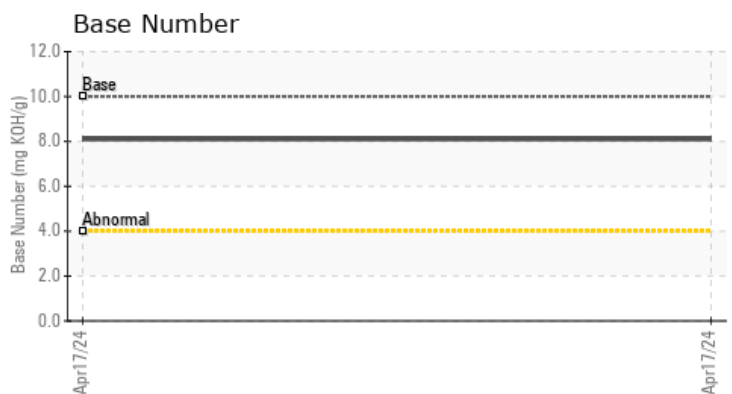
GRAPHS

Oil and filter change at the time of sampling has been noted. Resample at the next service interval to monitor. The copper level is abnormal. In the absence of other significant wear metals, suspect copper due to sources other than wear (i.e. cooling core). There is no indication of any contamination in the oil. The BN result indicates that there is suitable alkalinity remaining in the oil. The condition of the oil is acceptable for the time in service.
