600223 VOLVO L120H 632093 - TRANSMISSION (AUTO)

Sample No: VCP379875
Oil Type: VOLVO AUTOMATIC TRANSMISSION FLUID AT102
Job No: 600223

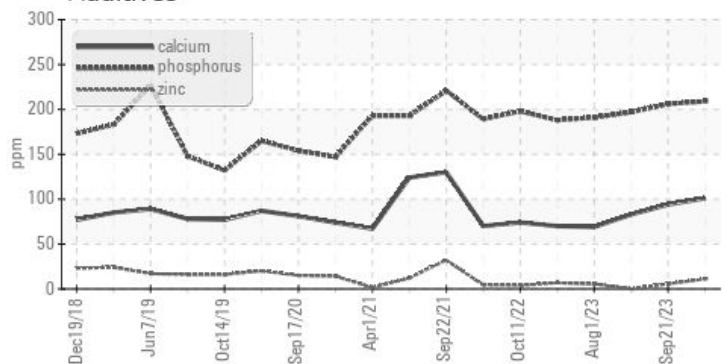
Additives

Calcium	ppm	101	94	83	69
Magnesium	ppm	<1	6	1	0
Zinc	ppm	11	6	0	5
Phosphorus	ppm	209	206	197	191
Barium	ppm	0	0	0	0
Boron	ppm	88	108	99	87
