CONSTRUCTION EQUIPMENT

SVC053895 VOLVO EC220E 3 10730 - FRONT RIGHT FINAL DRIVE

Sample No: VCP437547
Oil Type: VOLVO PREMIUM GEAR OIL 85W-140 GL-5
Job No: SVC053895

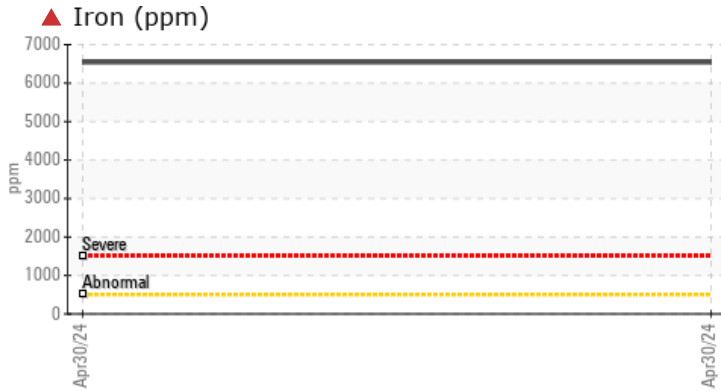
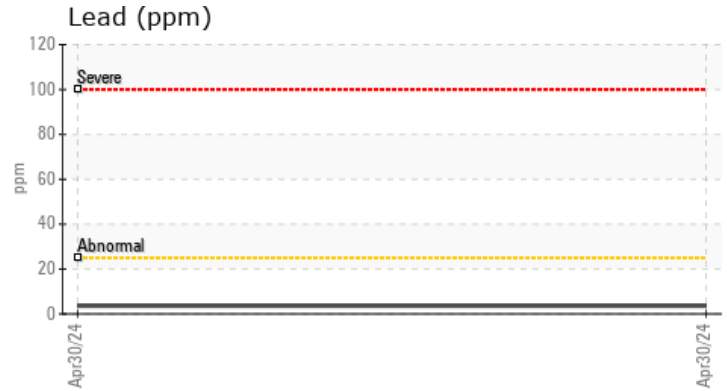
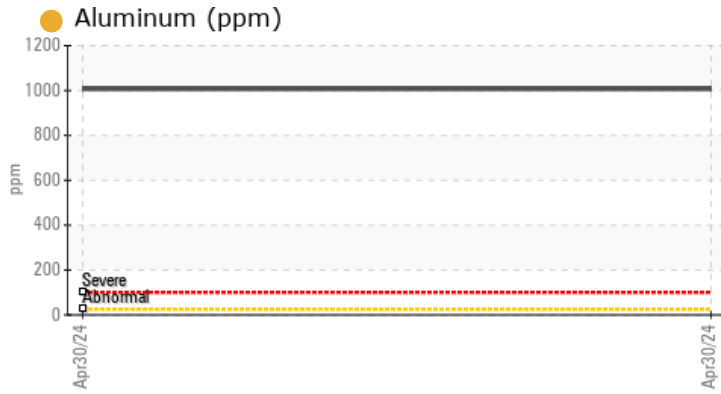
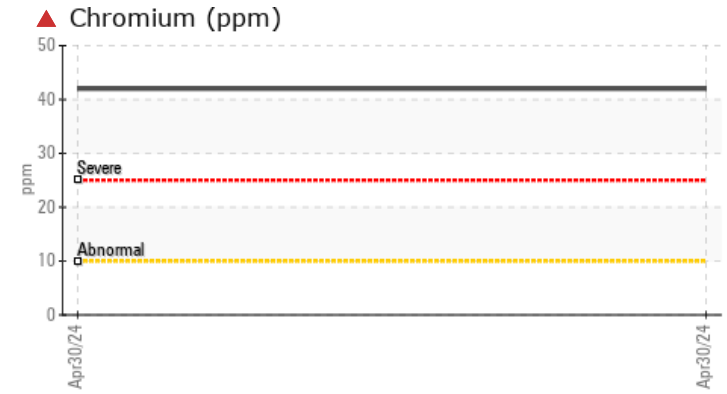
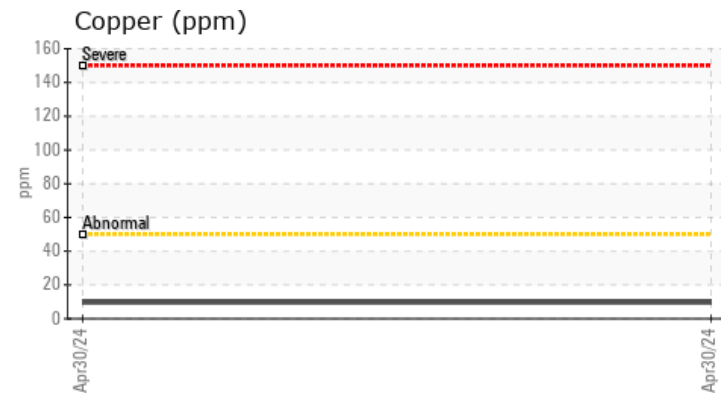
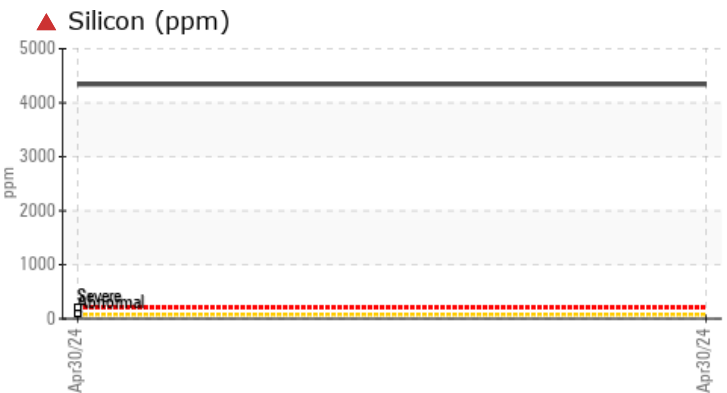
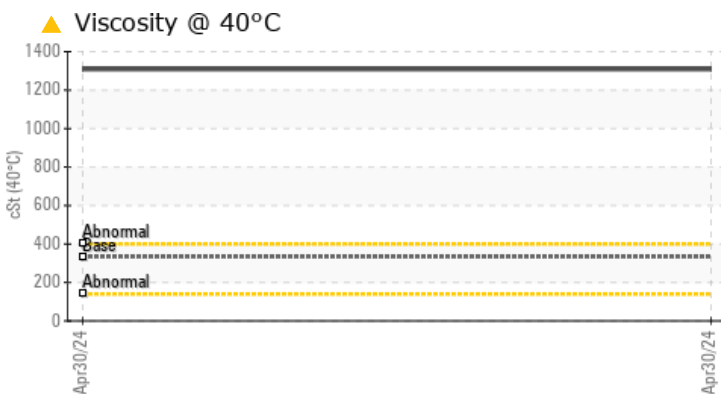
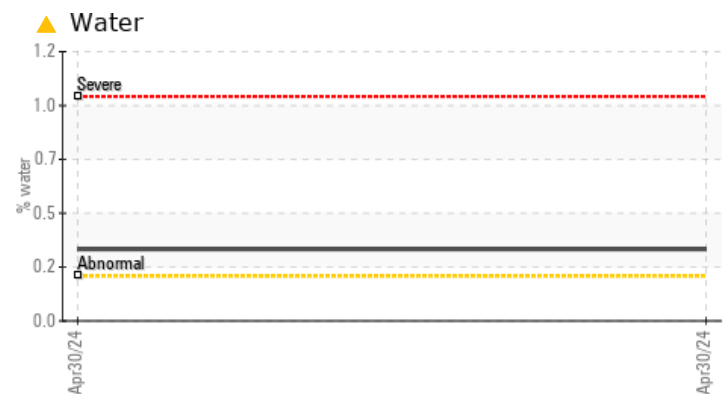
GRAPHS

We advise that you check all areas where dirt can enter the system. We recommend that you drain the oil from the component if this has not already been done. We advise that you inspect for the source(s) of wear. We recommend an early resample to monitor this condition. Gear wear is indicated. Elemental levels of silicon (Si) and aluminum (Al) indicate alumina-silicate (coarse dirt) ingress. There is a light concentration of water present in the oil. The oil viscosity is higher than normal. The oil is no longer serviceable as a result of the abnormal and/or severe wear.
