CONSTRUCTION EQUIPMENT

X59558 VOLVO EC300ELR 317660 - DIESEL ENGINE

Sample No: VCP437018
Oil Type: VOLVO ULTRA DIESEL ENGINE OIL 15W40 VDS-3
Job No: X59558

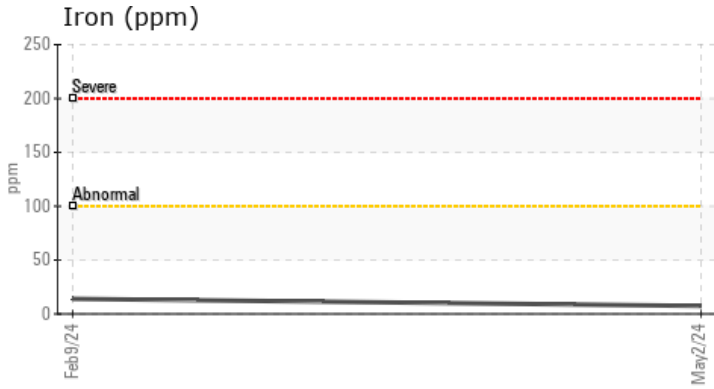
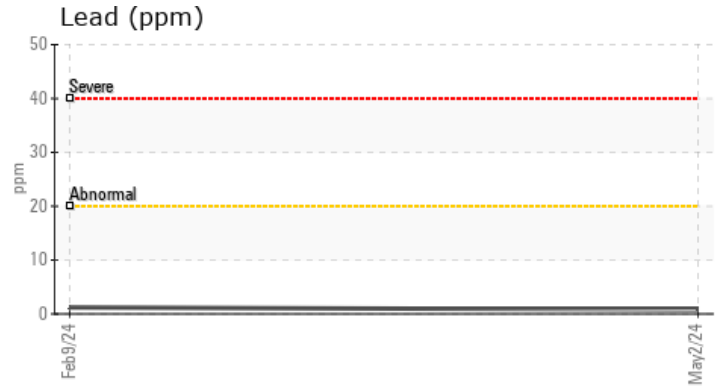
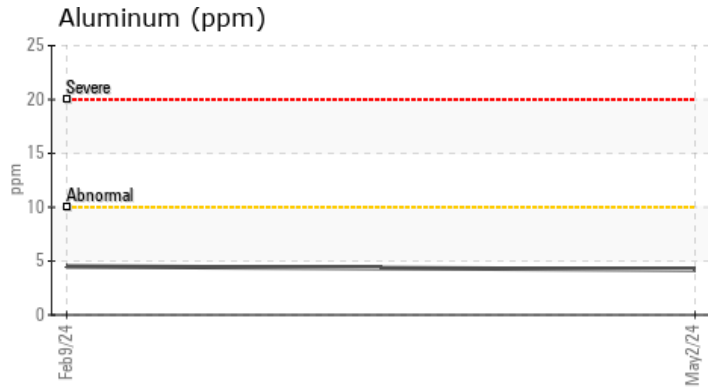
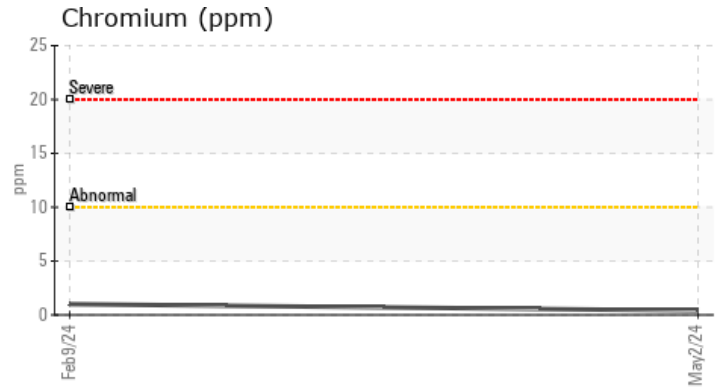
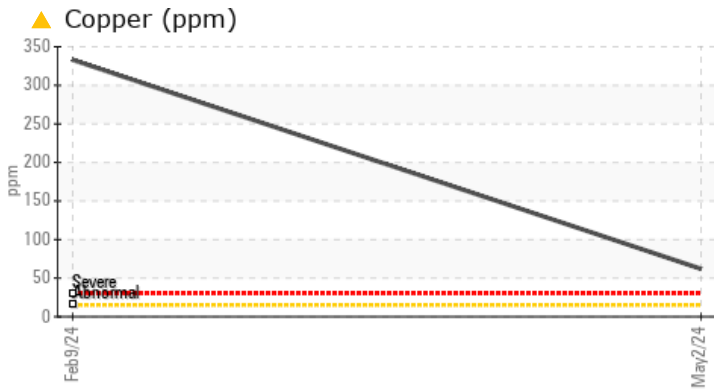
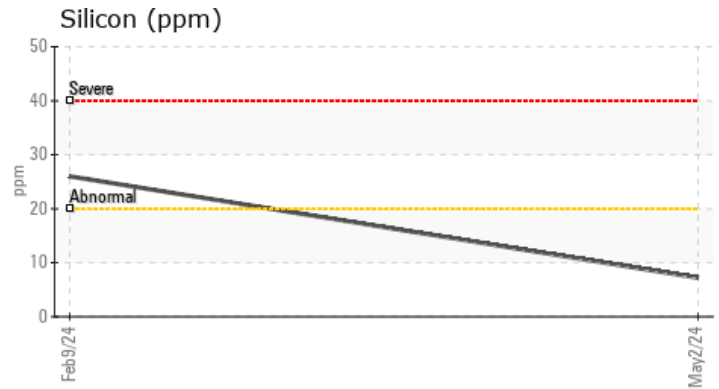
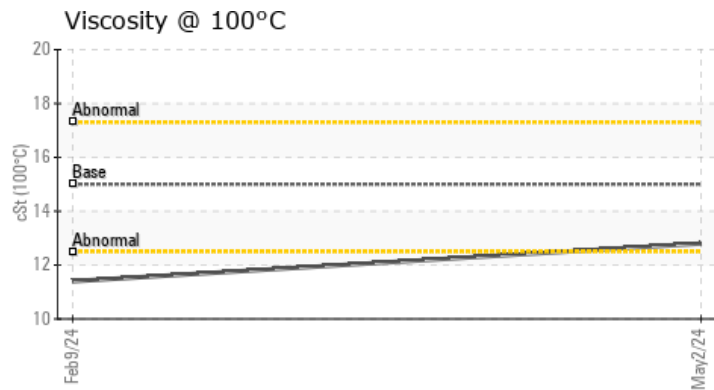
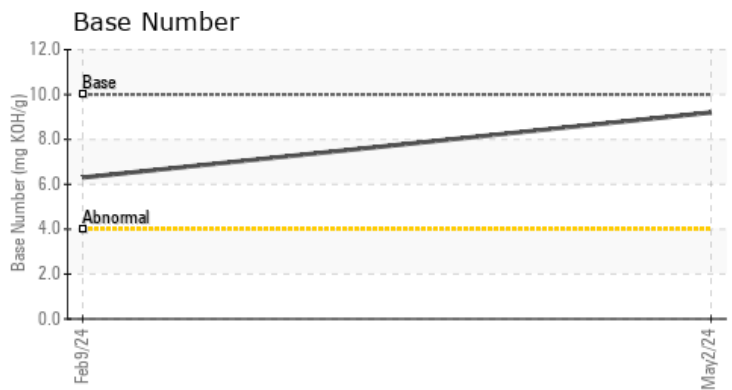
GRAPHS

No corrective action is recommended at this time. Resample at the next service interval to monitor. The copper level has decreased, but is still abnormal. In the absence of other significant wear metals, suspect copper due to sources other than wear (i.e. cooling core). All other component wear rates are normal. There is no indication of any contamination in the oil. The BN result indicates that there is suitable alkalinity remaining in the oil. The condition of the oil is suitable for further service.
