CONSTRUCTION EQUIPMENT

688690 VOLVO L150H 6059 - TRANSMISSION (AUTO)

Sample No: VCP437885
Oil Type: VOLVO AUTOMATIC TRANSMISSION FLUID AT102
Job No: 688690

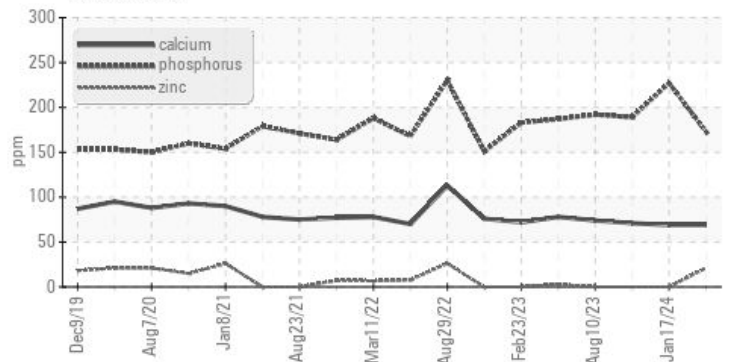
Additives

Calcium	ppm	69	69	71	74
Magnesium	ppm	3	<1	1	0
Zinc	ppm	21	0	0	0
Phosphorus	ppm	173	227	189	192
Barium	ppm	0	10	0	0
Boron	ppm	47	73	79	89
