CONSTRUCTION EQUIPMENT

VOLVO L220H 3065 - TRANSMISSION (AUTO)

Sample No: VCP440883D
Oil Type: PENNZOIL DEXRON MERCON ATF FLUID
Job No:

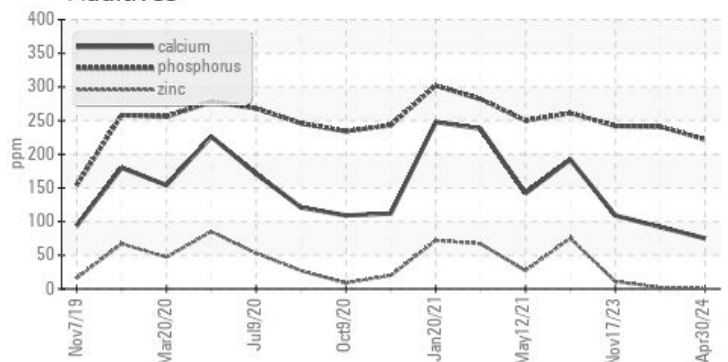
Additives

Calcium	ppm	75	92	109	192
Magnesium	ppm	0	2	4	23
Zinc	ppm	0	2	11	75
Phosphorus	ppm	222	241	242	261
Barium	ppm	0	<1	0	2
Boron	ppm	124	124	111	99
