HERC RENTALS VOLVO A30G 752902 - DIESEL ENGINE

Sample No: VCP437328
Oil Type: VOLVO ULTRA DIESEL ENGINE OIL 15W40 VDS-3
Job No: HERC RENTALS

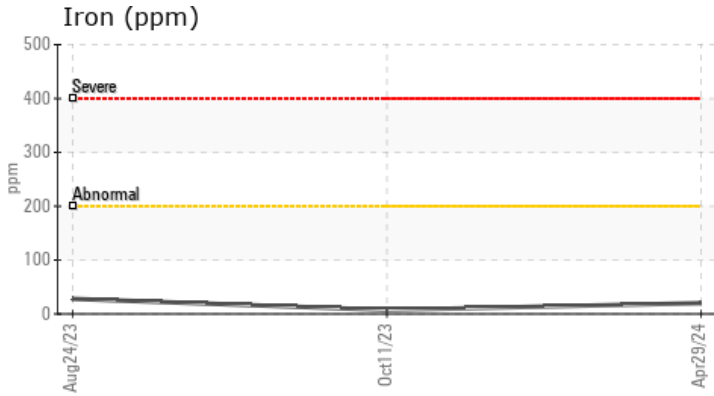
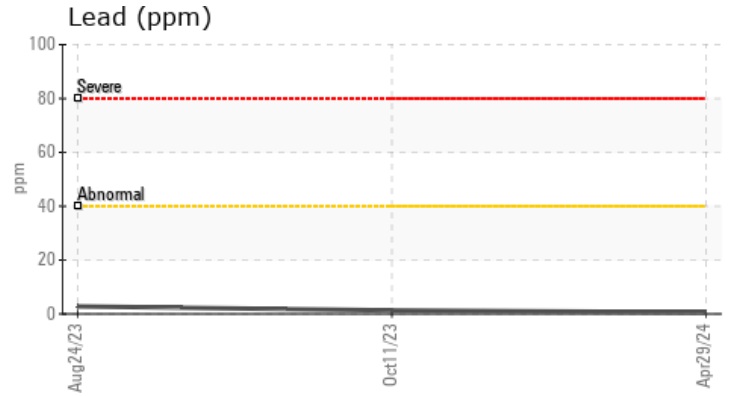
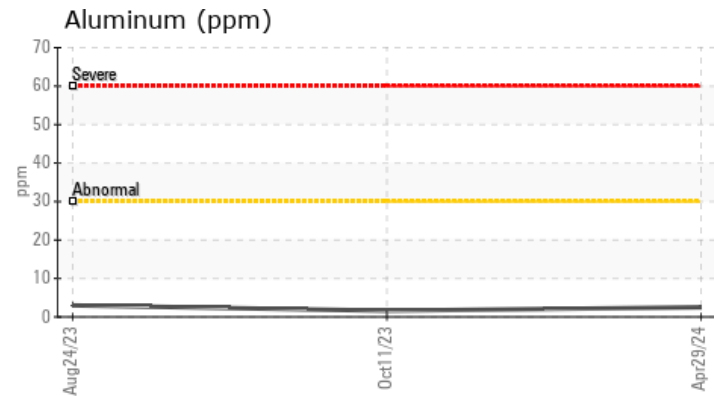
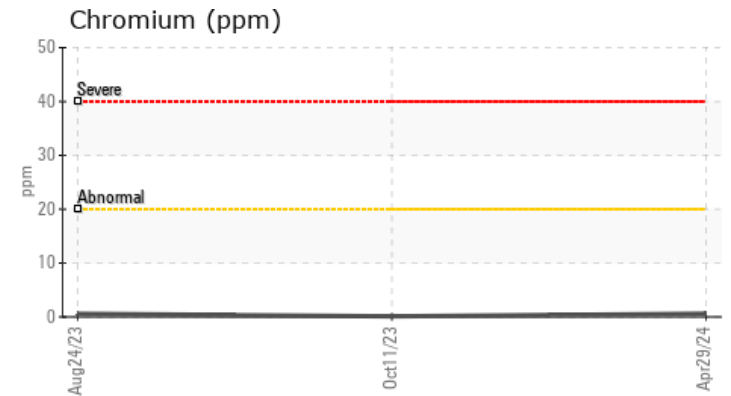
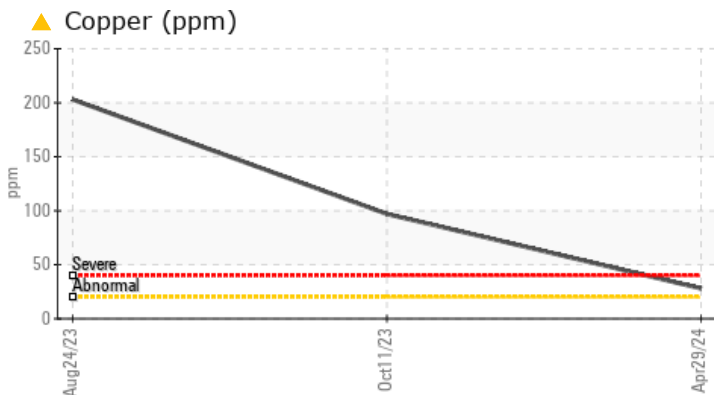
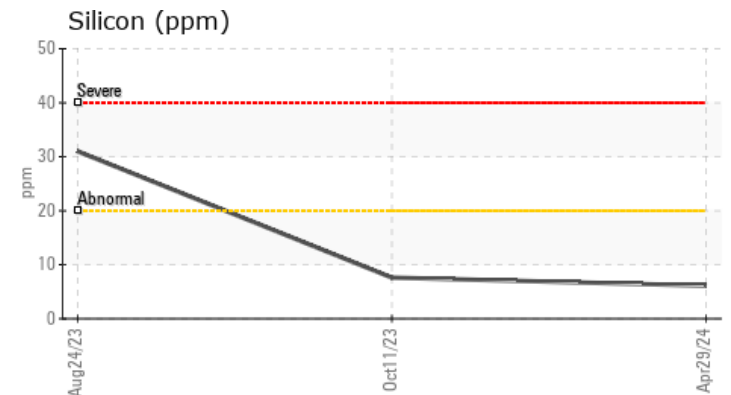
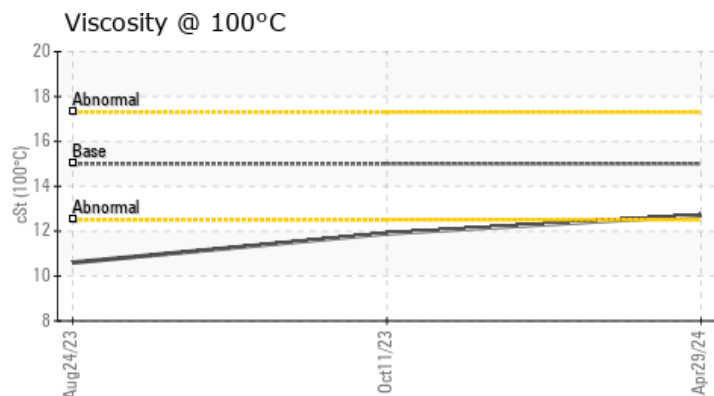
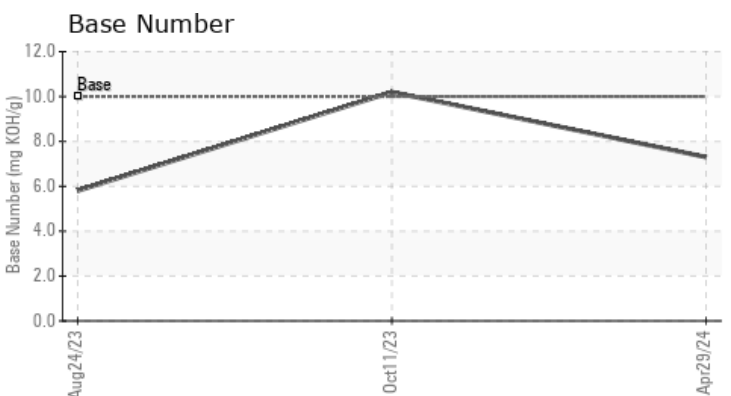
GRAPHS

Oil and filter change at the time of sampling has been noted. No corrective action is recommended at this time. Resample at the next service interval to monitor. The copper level has decreased, but is still abnormal. All other component wear rates are normal. There is no indication of any contamination in the oil. The BN result indicates that there is suitable alkalinity remaining in the oil. The condition of the oil is suitable for further service.
