# CONSTRUCTION EQUIPMENT

A12827 VOLVO L150H 7350 - TRANSMISSION (AUTO)

**Sample No:** VCP455091  
**Oil Type:** MOBIL ATF  
**Job No:** A12827

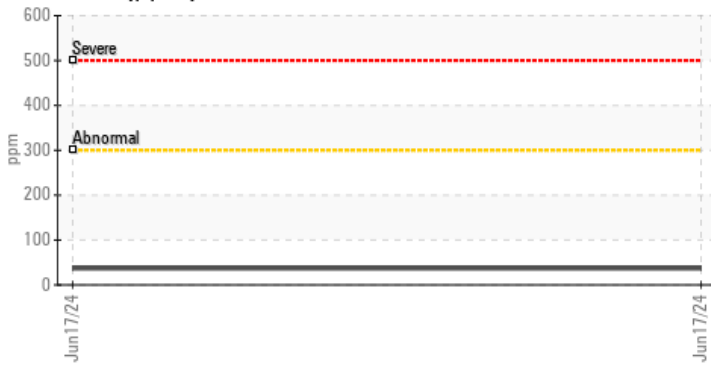
### Iron (ppm)

Iron	ppm	█ 37	---	---	---
Copper	ppm	█ 3	---	---	---
Lead	ppm	█ 0	---	---	---
Tin	ppm	█ 0	---	---	---
Aluminum	ppm	█ 2	---	---	---
Chromium	ppm	█ <1	---	---	---
Molybdenum	ppm	█ 0	---	---	---
Nickel	ppm	█ 0	---	---	---
Titanium	ppm	<1	---	---	---
Silver	ppm	█ 0	---	---	---
Manganese	ppm	█ 3	---	---	---
Vanadium	ppm	0	---	---	---

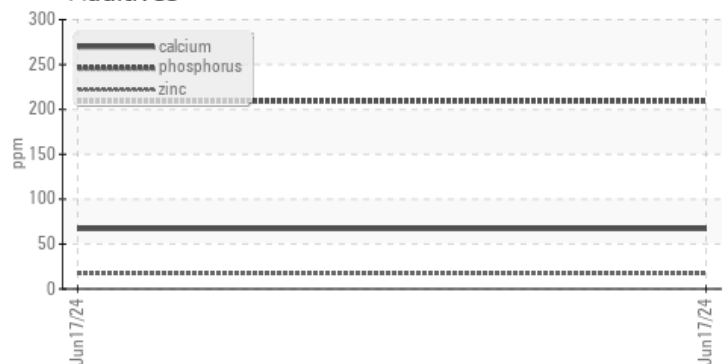
### Additives

Calcium	ppm	█ 67	---	---	---
Magnesium	ppm	█ 5	---	---	---
Zinc	ppm	█ 17	---	---	---
Phosphorus	ppm	█ 209	---	---	---
Barium	ppm	█ 4	---	---	---
Boron	ppm	█ 81	---	---	---
