CONSTRUCTION EQUIPMENT

VOLVO L90H 623836 - FRONT AXLE

Sample No: VCP440227
Oil Type: VOLVO WB 102
Job No:

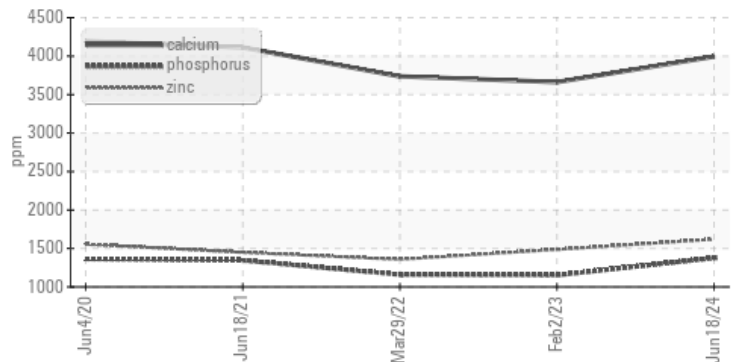
Additives

Calcium	ppm	3995	3662	3737	4113
Magnesium	ppm	37	35	36	9
Zinc	ppm	1621	1486	1357	1449
Phosphorus	ppm	1376	1153	1159	1345
Barium	ppm	1	0	0	0
Boron	ppm	128	130	126	152
