CONSTRUCTION EQUIPMENT

VOLVO A30G 742111 - TRANSMISSION (AUTO)

Sample No: VCP437296
Oil Type: VOLVO AT 102
Job No:

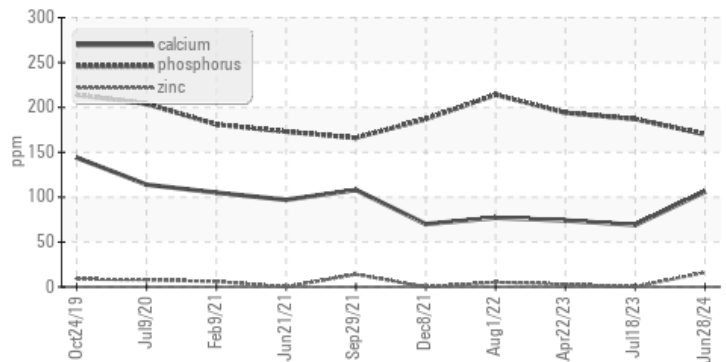
Additives

Calcium	ppm	106	69	74	77
Magnesium	ppm	2	2	4	<1
Zinc	ppm	16	0	3	5
Phosphorus	ppm	170	187	194	214
Barium	ppm	0	0	0	0
Boron	ppm	89	90	82	87
