CONSTRUCTION EQUIPMENT

5 VOLVO L110H 631239 - TRANSMISSION (AUTO)

Sample No: VCP438541
Oil Type: VOLVO AUTOMATIC TRANSMISSION FLUID AT102
Job No: 5

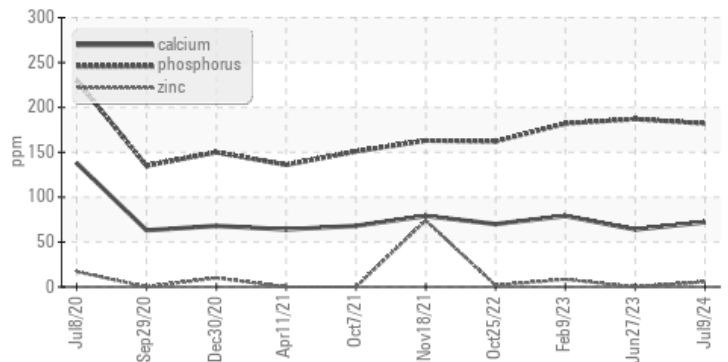
Additives

Calcium	ppm	72	64	79	70
Magnesium	ppm	0	0	0	2
Zinc	ppm	6	0	8	2
Phosphorus	ppm	182	187	182	162
Barium	ppm	0	0	0	0
Boron	ppm	80	93	89	67
