CONSTRUCTION EQUIPMENT

715594 VOLVO A40G 352851 - TRANSMISSION (AUTO)

Sample No: VCP444403
Oil Type: VOLVO AUTOMATIC TRANSMISSION FLUID AT102
Job No: 715594

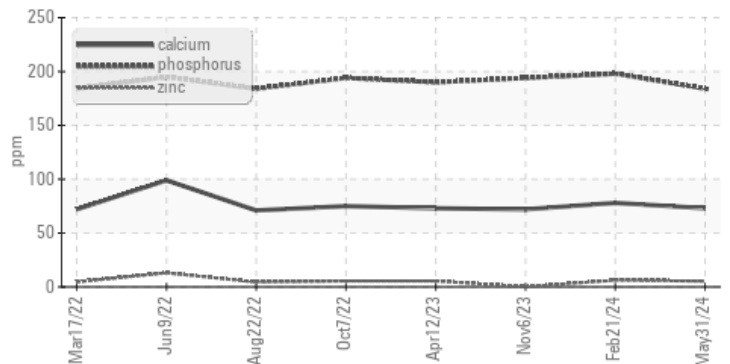
Additives

Calcium	ppm	73	78	72	73
Magnesium	ppm	1	<1	2	<1
Zinc	ppm	5	6	0	6
Phosphorus	ppm	184	198	194	190
Barium	ppm	0	0	0	0
Boron	ppm	84	92	66	80
