# OIL ANALYSIS REPORT

**19228 VOLVO 2013765144 - PORT DIESEL ENGINE**

**Sample No:** VPA041251

**Oil Type:** VOLVO ULTRA DIESEL ENGINE OIL 15W40 VDS-3

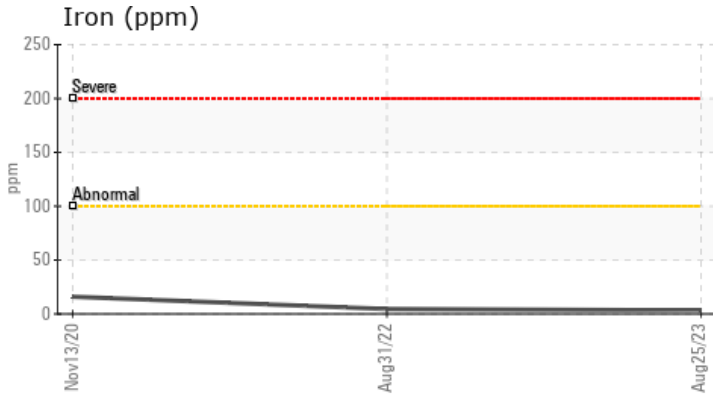
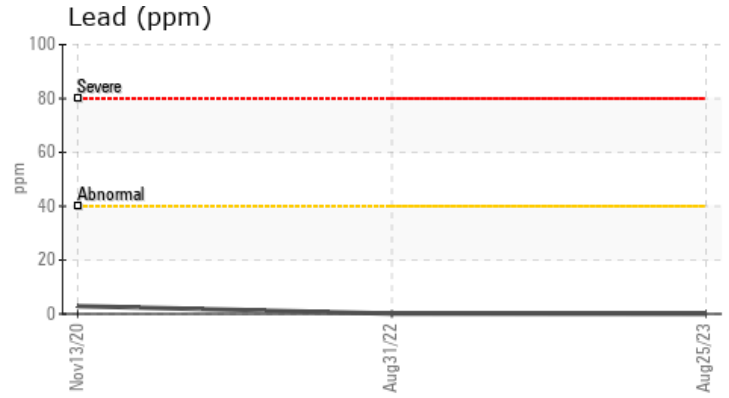
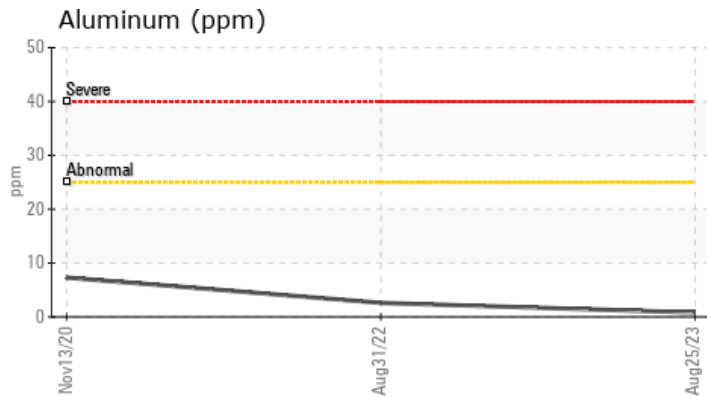
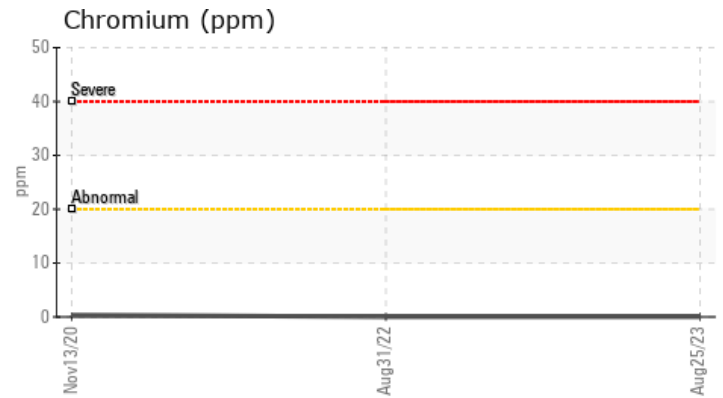
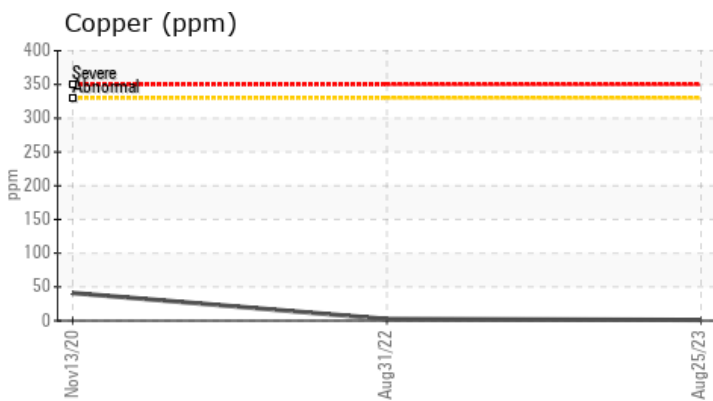
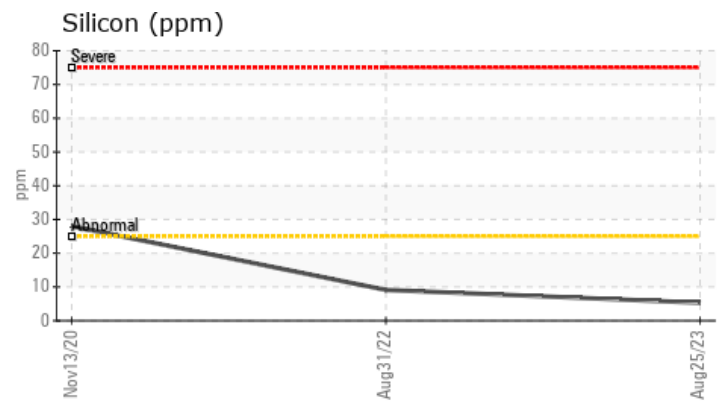
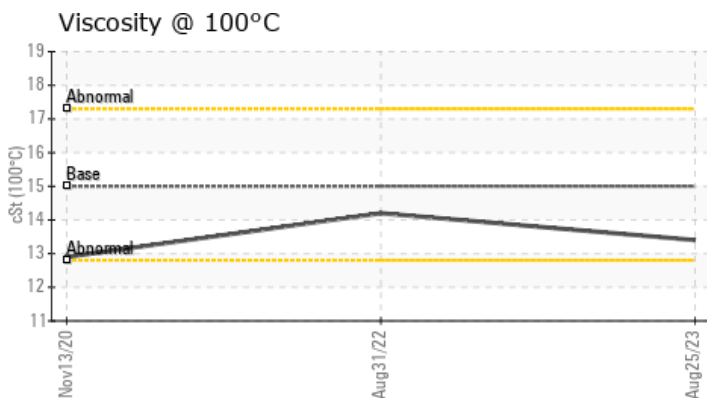
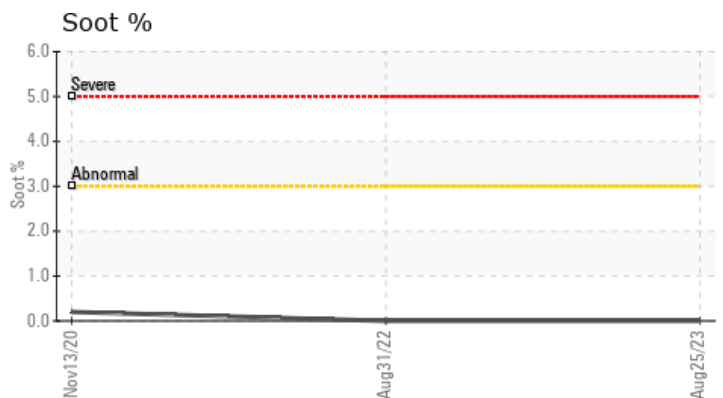
## GRAPHS

Confirm the source of the lubricant being utilized for top-up/fill. Resample at the next service interval to monitor. All component wear rates are normal. There is no indication of any contamination in the oil. Additive levels indicate the addition of a different brand, or type of oil. The condition of the oil is acceptable for the time in service.
