# OIL ANALYSIS REPORT

**TYLER/H.R. 1013720600 - PORT DIESEL ENGINE**

**Sample No:** VPA046646  
**Oil Type:** MOBIL DELVAC 1300 SUPER15W40

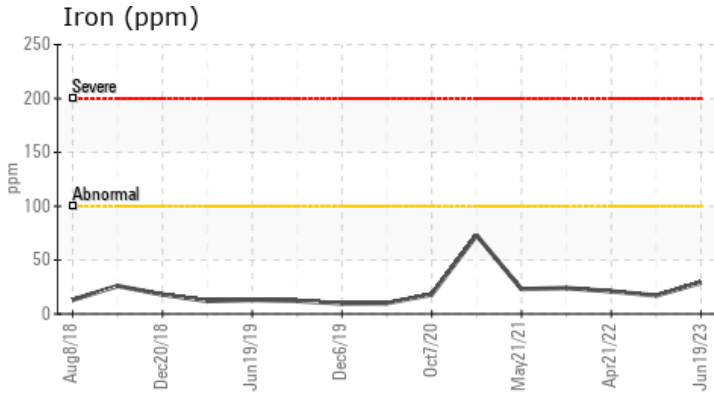
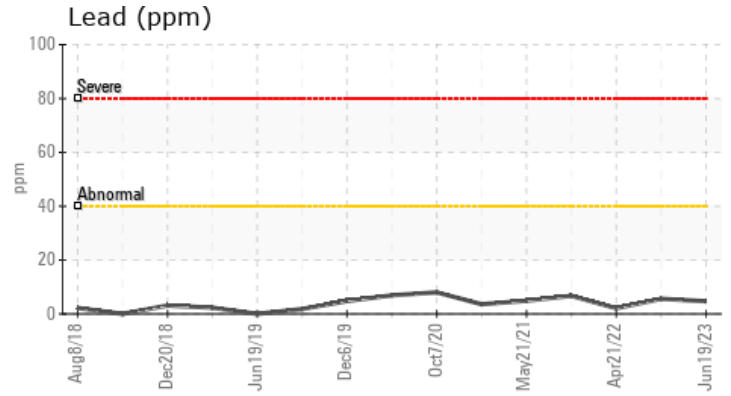
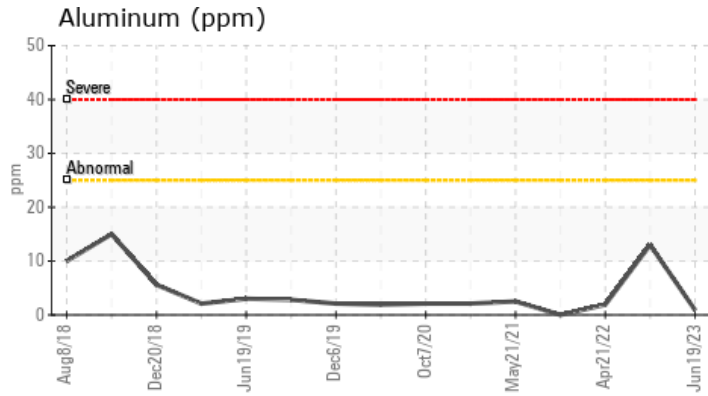
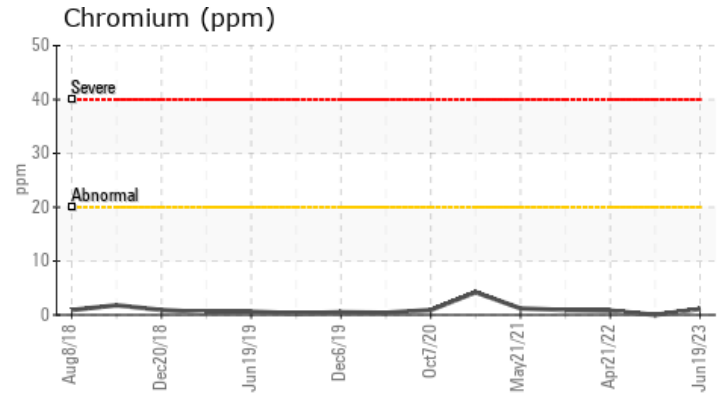
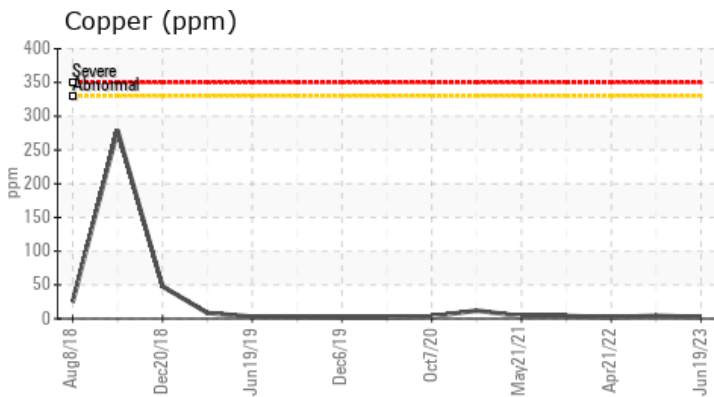
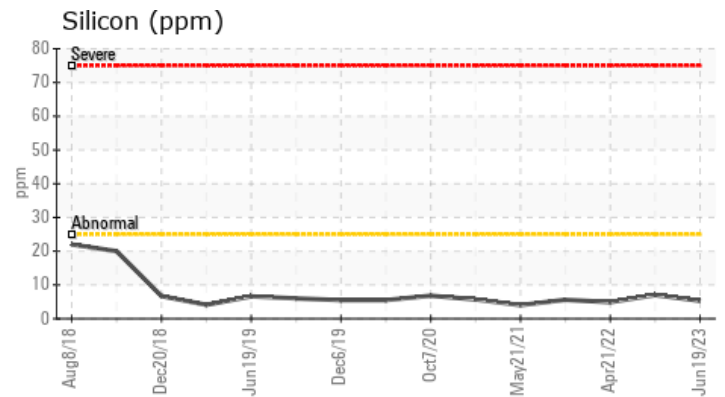
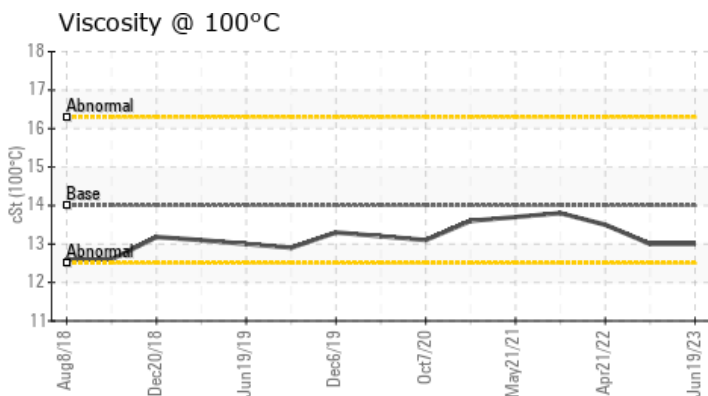
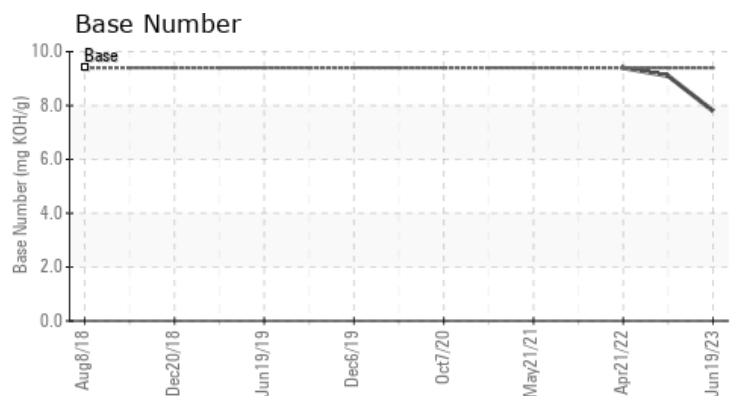
## GRAPHS

Resample at the next service interval to monitor. All component wear rates are normal. There is no indication of any contamination in the oil. The BN result indicates that there is suitable alkalinity remaining in the oil. The condition of the oil is suitable for further service.
