Customer Id: GRAGRARP
Sample No.: RP006486
Lab Number: 00234382
Test Package: IND 2

OIL ANALYSIS REPORT

Area
[PRO SEAL]
 Machine Id
1A CONVEYOR
 Component
Gearbox
 Fluid

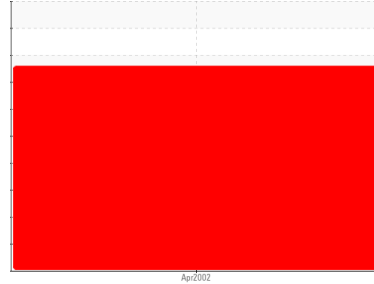
Sample Rating Trend

WEAR

The aluminum level is severe. All other component wear rates are normal.

The TAN level is at the top-end of the recommended limit. The oil viscosity is lower than normal.

The oil is near the end of its useful service life, recommend schedule an oil change. We recommend an early resample to monitor this condition.

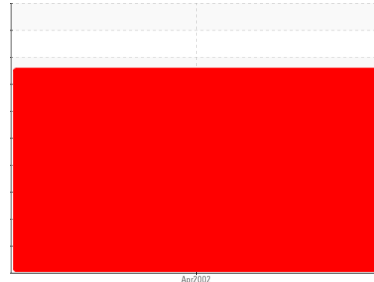
Sample Rating Trend

There is no indication of any contamination in the component.

The oil is near the end of its useful service life, recommend schedule an oil change. We recommend an early resample to monitor this condition.
