OIL ANALYSIS REPORT

Machine Id
#7 NH3 Compressor Motor
 Component
Inboard Bearing
 Fluid
PETRO CANADA PREMIUM R&O 68 (1 LTR)

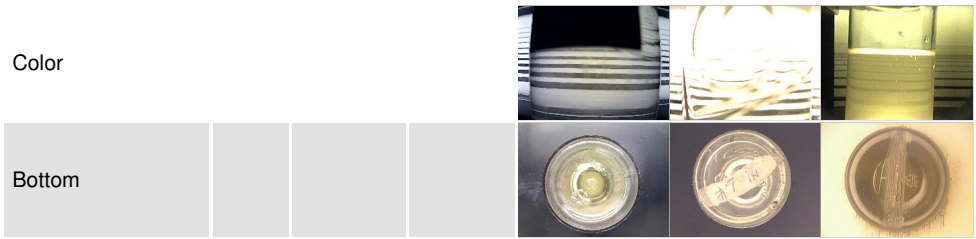
SAMPLE IMAGES	method	limit/base	current	history1	history2
---------------	--------	------------	---------	----------	----------

VISUAL	method	limit/base	current	history1	history2
White Metal	scalar	Visual*	NONE	NONE	NONE
Yellow Metal	scalar	Visual*	NONE	NONE	NONE
Precipitate	scalar	Visual*	NONE	NONE	NONE
Silt	scalar	Visual*	NONE	NONE	VLITE
Debris	scalar	Visual*	NONE	NONE	LIGHT
Sand/Dirt	scalar	Visual*	NONE	NONE	NONE
Appearance	scalar	Visual*	NORML	NORML	NORML
Odor	scalar	Visual*	NORML	NORML	AMMON
Emulsified Water	scalar	Visual*	>2	NEG	NEG
Free Water	scalar	Visual*		NEG	NEG
