OIL ANALYSIS REPORT

Area
Gary Steacy - G02900
 Machine Id
A2308045
 Component
Transformer Oil
 Fluid
NOT GIVEN (--- GAL)

Laboratory : WearCheck - C8-1175 Appleby Line, Burlington, ON L7L 5H9
Sample No. : E30000093 **Received** : 17 Aug 2023
Lab Number : **02576610** **Diagnosed** : 28 Aug 2023
Unique Number : 5629670 **Diagnostician** : Tatiana Sorkina
Test Package : TEST (Additional Tests: ICP, PCBtransformer)

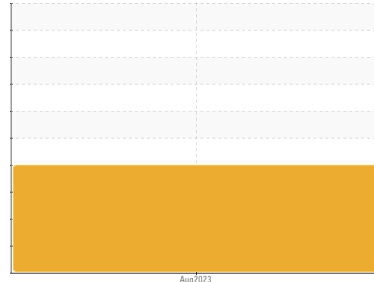
Sample Rating Trend

- ▲ **Recommendation**
 This is a baseline read-out on the submitted sample. (Customer Sample Comment: PCB, ICP)
- Wear**
 {not applicable}
- ▲ **Contamination**
 {not applicable}
- Fluid Condition**
 {not applicable}

method	limit/base	current	history1	history2
Silicon	ppm	ASTM D5185(m) >25	<1	---	---
Sodium	ppm	ASTM D5185(m)	0	---	---
Potassium	ppm	ASTM D5185(m) >20	<1	---	---
PCBs	ppm		▲ 2.6	---	---
