OIL ANALYSIS REPORT

Area
Windmill Plastics - W02200
 Machine Id
A2308109
 Component
Hydraulic System
 Fluid
AW HYDRAULIC OIL ISO 46 (--- GAL)

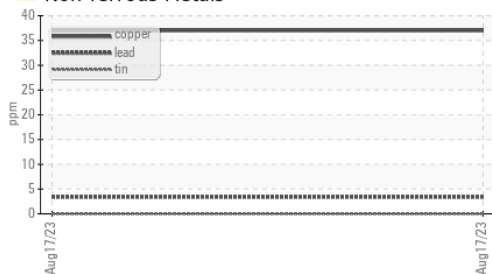
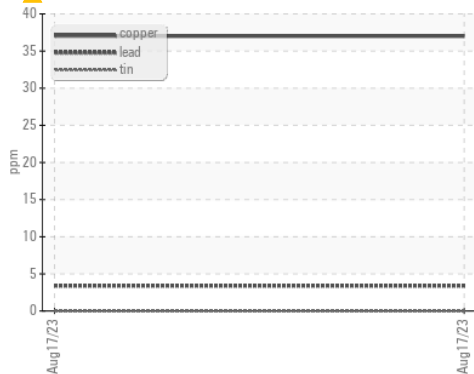
▲ Non-ferrous Metals

Copper and iron ppm levels are noted.

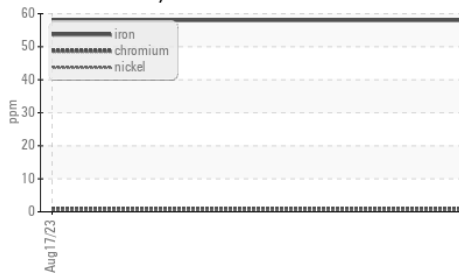
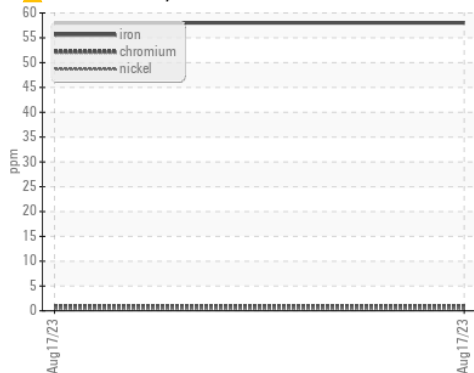
▲ Ferrous Alloys

method	limit/base	current	history1	history2
PQ	ASTM D8184*		0	---	---
Iron	ppm	ASTM D5185(m) >20	▲ 58	---	---
Chromium	ppm	ASTM D5185(m) >10	1	---	---
Nickel	ppm	ASTM D5185(m) >10	<1	---	---
Titanium	ppm	ASTM D5185(m)	0	---	---
Silver	ppm	ASTM D5185(m)	0	---	---
Aluminum	ppm	ASTM D5185(m) >10	<1	---	---
Lead	ppm	ASTM D5185(m) >20	3	---	---
Copper	ppm	ASTM D5185(m) >20	▲ 37	---	---
Tin	ppm	ASTM D5185(m) >10	0	---	---
Antimony	ppm	ASTM D5185(m)	0	---	---
Vanadium	ppm	ASTM D5185(m)	0	---	---
Beryllium	ppm	ASTM D5185(m)	0	---	---
Cadmium	ppm	ASTM D5185(m)	<1	---	---

This is a baseline read-out on the submitted sample.
