# PROBLEM SUMMARY

Machine Id  
**CLOVER SCREEN 110 #1**  
 Component  
**Gearbox**  
 Fluid  
**CLP HC 460 (--- GAL)**

# OIL ANALYSIS REPORT

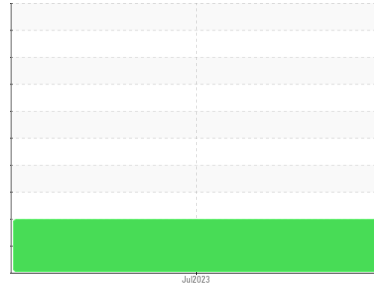
Sample Rating Trend

**WEAR**

Copper and tin ppm levels are abnormal. Bearing and/or bushing wear is indicated.

Viscosity of sample indicates oil is within SAE 50 range, advise investigate. The oil is no longer serviceable as a result of the abnormal and/or severe wear.

We recommend that you drain the oil from the component if this has not already been done. We recommend an early resample to monitor this condition.

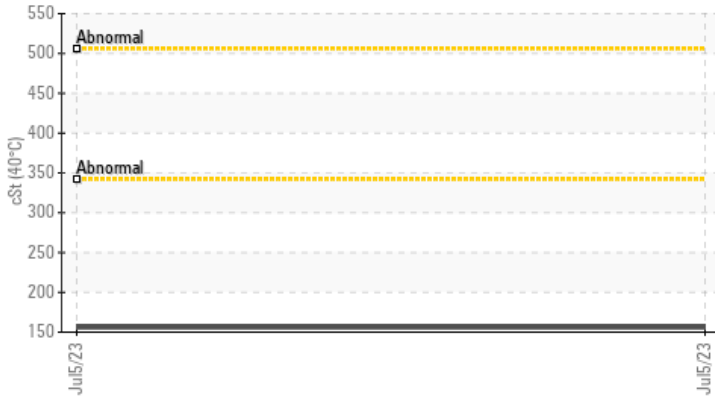
### ▲ Viscosity @ 40°C

Sample Status				<b>ABNORMAL</b>	---	---
Copper	ppm	ASTM D5185(m)	>200	▲ <b>226</b>	---	---
Tin	ppm	ASTM D5185(m)	>10	▲ <b>32</b>	---	---
Visc @ 40°C	cSt	ASTM D7279(m)		▲ <b>156</b>	---	---

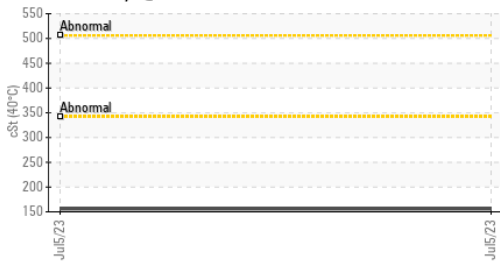
### ▲ Viscosity @ 40°C

Property	Method	Limit/Base	Current	History 1	History 2
Visc @ 40°C	cSt	ASTM D7279(m)	▲ 156	---	---
