Area
Direct Strip Mill/Finishing
 Machine Id
72" GRINDER HYDRAULIC SYSTEM (DSC013)
 Component
Hydraulic System
 Fluid
SHELL TELLUS S2 MX 46 (675 LTR)

Customer Id: ALGSSM
 Sample No.: WC0837457
 Lab Number: 02586181
 Test Package: IND 2

OIL ANALYSIS REPORT

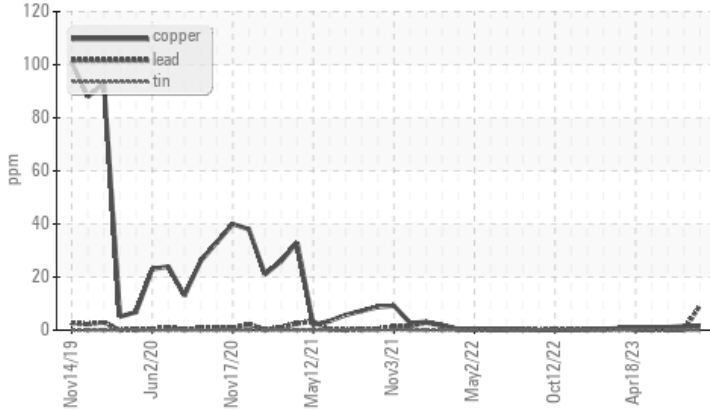
COMPONENT CONDITION SUMMARY

▲ Non-ferrous Metals

Sample Status				ABNORMAL	NORMAL	NORMAL
Lead	ppm	ASTM D5185(m)	>10	▲ 9	0	0

Lead ppm levels are abnormal. A sharp increase in the lead level is noted. Bearing wear is indicated.

We recommend an early resample to monitor this condition.
