Machine Id
CATERPILLAR PL01 (S/N 0336KYBN10625)
 Component
Hydraulic System
 Fluid
PANOLIN HLP SYNTH 46 (260 LTR)

Customer Id: CLESAL
 Sample No.: WC0861332
 Lab Number: 02587149
 Test Package: IND 2

OIL ANALYSIS REPORT

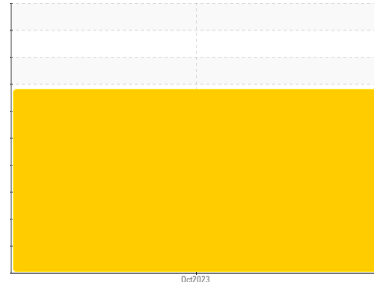
Sample Rating Trend

Sample Status				SEVERE	---	---
Iron	ppm	ASTM D5185(m)	>20	▲ 70	---	---
Calcium	ppm	ASTM D5185(m)	0	▲ 178	---	---
Phosphorus	ppm	ASTM D5185(m)	1700	▲ 707	---	---
Zinc	ppm	ASTM D5185(m)	0	▲ 921	---	---
Particles >4µm		ASTM D7647	>2500	● 124902	---	---
Particles >6µm		ASTM D7647	>640	● 31013	---	---
Particles >14µm		ASTM D7647	>80	▲ 379	---	---
Particles >21µm		ASTM D7647	>20	▲ 35	---	---
Oil Cleanliness		ISO 4406 (c)	>18/16/13	● 24/22/16	---	---
Visc @ 40°C	cSt	ASTM D7279(m)	47.0	▲ 39.1	---	---

Vérifier les scelles et/ou les filters pour des points d'entrée des contaminants. Le reniflard d'air doit être réparé. S'il n'est pas classé, nous vous recommandons de le remplacer par un reniflard à air adapté au micron et / ou au dessicant. Si évalué, nous vous recommandons de réparer / remplacer le reniflard. Nous recommandons le remplacement des filtres de ce composant. Confirm the source of the lubricant being utilized for top-up/fill. Échantillonner de nouveau dans 30 à 45 jours afin de contrôler la situation.

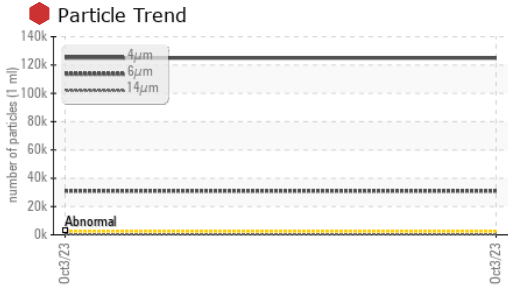
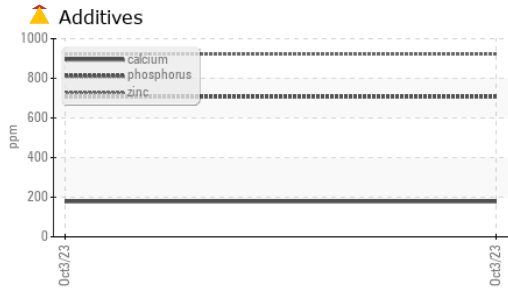
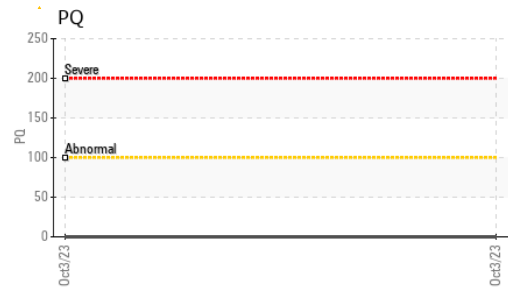
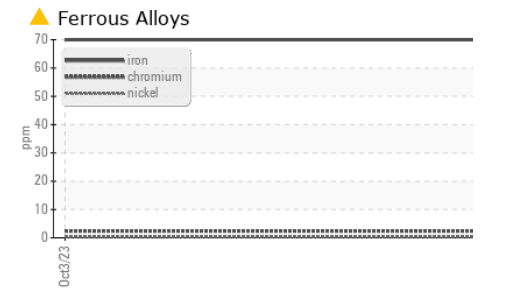
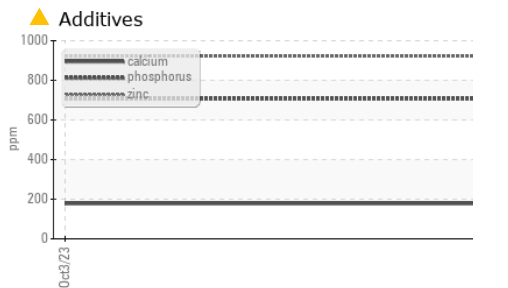
GRAPHS

Le taux de fer est anormal. Le bas indice ferreux (PQ) indique que l'usure ferreuse est due à de la corrosion.

Il y a une grande quantité de limon (particules de 4 à 14 microns) dans l'huile. Le code de propreté du système est beaucoup plus haut que la limite acceptable pour votre objectif de propreté ISO 4406.

La viscosité de l'échantillon se situe dans la portée de l'SAE 70W80; nous vous conseillons de vérifier. Ceci, en plus des niveaux d'additifs, indique que la marque ou le type d'huile ne correspond pas à ce qui a été signalé. Le AN est acceptable pour ce fluide. l'huile peut encore servir si la contamination peut être réduite à un niveau acceptable.

method	limit/base	current	history1	history2
Particles >4µm	ASTM D7647	>2500	124902	---	---
Particles >6µm	ASTM D7647	>640	31013	---	---
Particles >14µm	ASTM D7647	>80	379	---	---
Particles >21µm	ASTM D7647	>20	35	---	---
Particles >38µm	ASTM D7647	>4	1	---	---
Particles >71µm	ASTM D7647	>3	1	---	---
Oil Cleanliness	ISO 4406 (c)	>18/16/13	24/22/16	---	---

Vérifier les scelles et/ou les filtres pour des points d'entrée des contaminants. Le reniflard d'air doit être réparé. S'il n'est pas classé, nous vous recommandons de le remplacer par un reniflard à air adapté au micron et / ou au dessiccant. Si évalué, nous vous recommandons de réparer / remplacer le reniflard. Nous recommandons le remplacement des filtres de ce composant. Confirm the source of the lubricant being utilized for top-up/fill. Échantillonner de nouveau dans 30 à 45 jours afin de contrôler la situation.
