VISUAL METAL

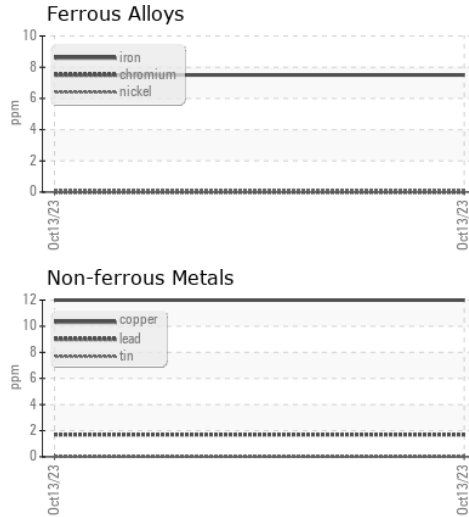
GRAPHS

method	limit/base	current	history1	history2
Iron	ppm	ASTM D5185(m) >20	8	---	---
Chromium	ppm	ASTM D5185(m) >10	0	---	---
Nickel	ppm	ASTM D5185(m) >10	<1	---	---
Titanium	ppm	ASTM D5185(m)	0	---	---
Silver	ppm	ASTM D5185(m)	<1	---	---
Aluminum	ppm	ASTM D5185(m) >10	2	---	---
Lead	ppm	ASTM D5185(m) >20	2	---	---
Copper	ppm	ASTM D5185(m) >20	12	---	---
Tin	ppm	ASTM D5185(m) >10	0	---	---
Antimony	ppm	ASTM D5185(m)	0	---	---
Vanadium	ppm	ASTM D5185(m)	0	---	---
Beryllium	ppm	ASTM D5185(m)	0	---	---
Cadmium	ppm	ASTM D5185(m)	0	---	---
