Area
Chem-Ecol
 Machine Id
A2310079
 Component
Unknown Component
 Fluid
CHEM-ECOL LUBECUT 101 (--- GAL)

Customer Id: CHECOB
 Sample No.: E30000520
 Lab Number: 02590069
 Test Package: IND 2

OIL ANALYSIS REPORT

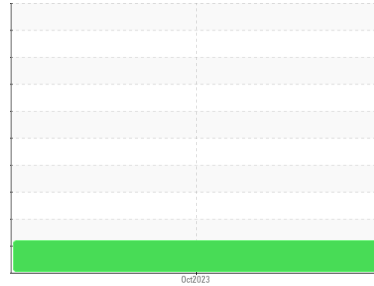
Sample Rating Trend

▲ Particle Trend

| Sample Status | | | ABNORMAL | --- | --- |
|---|---|---|---|---|---|
| Particles >4µm | ASTM D7647 | >5000 | ▲ 28116 | --- | --- |
| Particles >6µm | ASTM D7647 | >1300 | ▲ 4888 | --- | --- |
| Oil Cleanliness | ISO 4406 (c) | >19/17/14 | ▲ 22/19/13 | --- | --- |

This is a baseline read-out on the submitted sample.
