# OIL ANALYSIS REPORT

Area  
**SAB2**  
 Machine Id  
**SAB2 G25 Governor Lube**  
 Component  
**Governor System**  
 Fluid  
**ESSO TERESSO ISO 46 (6160 LTR)**

**Ontario Power Generation**  
 NIAGARA PLANT GROUP, 14000 NIAGARA PKWY  
 NIAGARA ON THE LAKE, ON  
 CA L0S 1J0  
 Contact: Alex Courtemanche  
 alex.courtemanche@opg.com  
 T: (905)357-0322  
 F: (905)357-6558

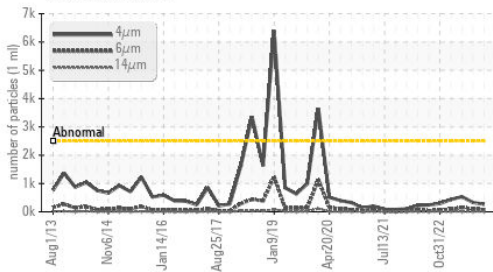
**Particle Trend**

method	limit/base	current	history1	history2	
Particles >4µm	ASTM D7647	>2500	<b>268</b>	329	533
Particles >6µm	ASTM D7647	>640	<b>73</b>	103	154
Particles >14µm	ASTM D7647	>80	<b>6</b>	13	11
Particles >21µm	ASTM D7647	>20	<b>2</b>	3	2
Particles >38µm	ASTM D7647	>4	<b>1</b>	0	0
Particles >71µm	ASTM D7647	>3	<b>1</b>	0	0
Oil Cleanliness	ISO 4406 (c)	>18/16/13	<b>15/13/10</b>	16/14/11	16/14/11

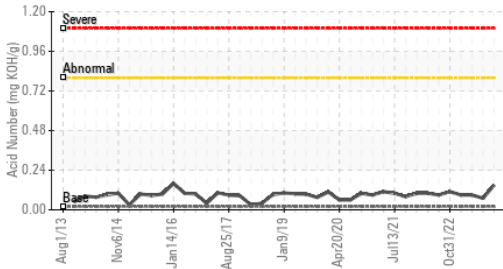
**Acid Number**

The AN level is acceptable for this fluid. The condition of the oil is suitable for further service.

method	limit/base	current	history1	history2	
Acid Number (AN)	mg KOH/g	ASTM D974* 0.02	<b>0.15</b>	0.07	0.09

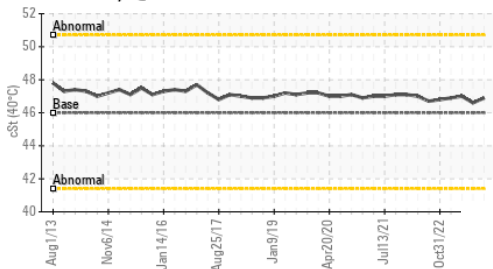
**Viscosity @ 40°C**

FLUID PROPERTIES	method	limit/base	current	history1	history2	
Visc @ 40°C	cSt	ASTM D7279(m)	46	<b>46.9</b>	46.6	47.0
