# OIL ANALYSIS REPORT

Machine Id  
**EG017**  
 Component  
**Hydraulic System**  
 Fluid  
**NOT GIVEN (--- LTR)**

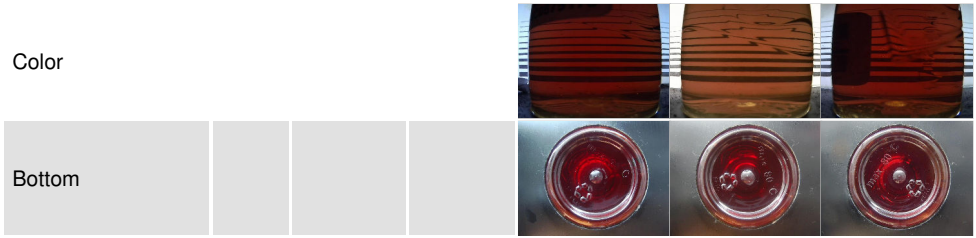
### SAMPLE IMAGES

VISUAL		method	limit/base	current	history1	history2
White Metal	scalar	Visual*	NONE	<b>NONE</b>	NONE	NONE
Yellow Metal	scalar	Visual*	NONE	<b>NONE</b>	NONE	NONE
Precipitate	scalar	Visual*	NONE	<b>NONE</b>	NONE	NONE
Silt	scalar	Visual*	NONE	<b>NONE</b>	NONE	NONE
Debris	scalar	Visual*	NONE	<b>NONE</b>	NONE	NONE
Sand/Dirt	scalar	Visual*	NONE	<b>NONE</b>	NONE	NONE
Appearance	scalar	Visual*	NORML	<b>NORML</b>	NORML	NORML
Odor	scalar	Visual*	NORML	<b>NORML</b>	NORML	NORML
Emulsified Water	scalar	Visual*	>0.05	<b>NEG</b>	NEG	NEG
Free Water	scalar	Visual*		<b>NEG</b>	NEG	NEG

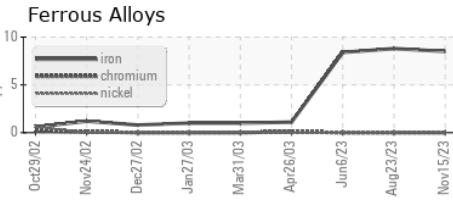
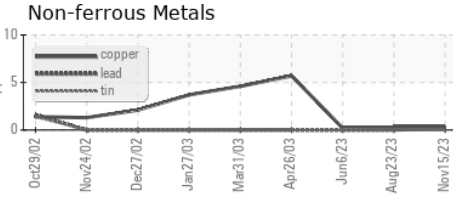
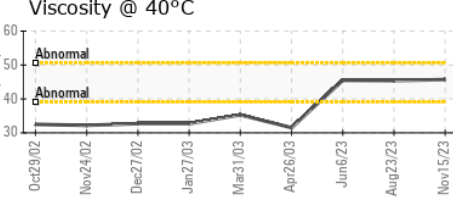
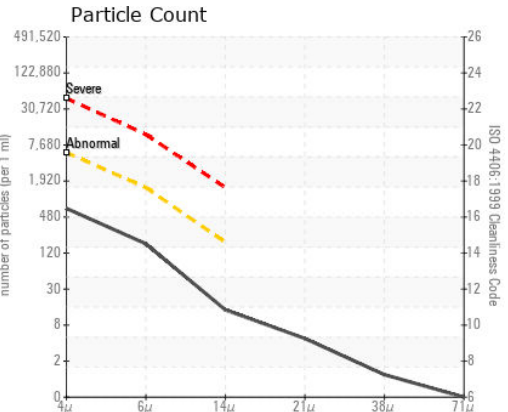
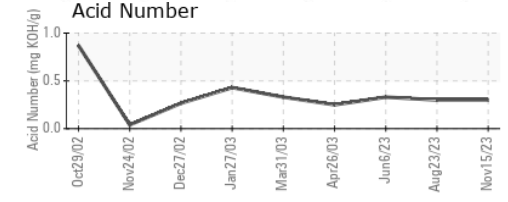
### GRAPHS

Les taux d'usure de tous les composants sont normaux.

La propreté du système est acceptable pour votre objectif de propreté ISO 4406. La propreté du système et du fluide est acceptable.

Le AN est acceptable pour ce fluide. L'état de l'huile permet d'en prolonger l'utilisation.

Échantillonner de nouveau l'équipement au prochain intervalle de vidange afin d'en surveiller la condition. À NOTER: S.V.P. inclure, avec le prochain échantillon, des détails de la capacité du réservoir et le type et le degré de filtration. Veuillez préciser la marque, le type et la viscosité de l'huile lors de votre prochain échantillon.
