# OIL ANALYSIS REPORT

Machine Id  
**170832 (S/N GH-9162B)**

Component  
**Slewing Gearbox**

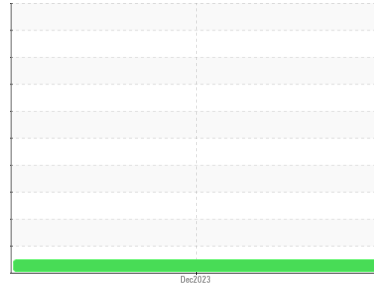
Sample Rating Trend

**NORMAL**

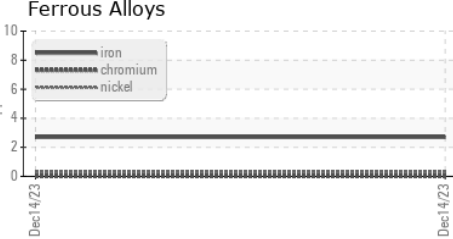
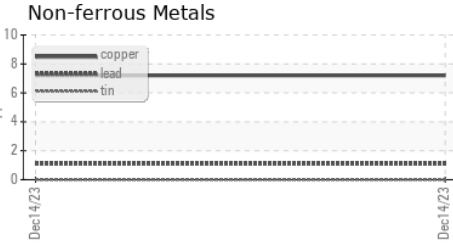
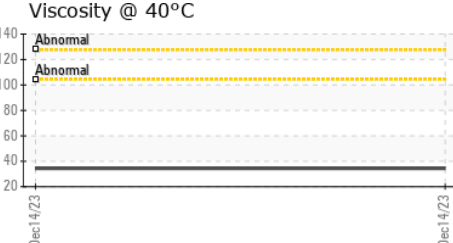
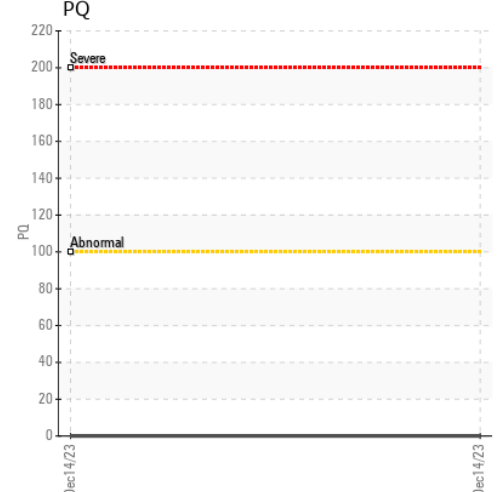
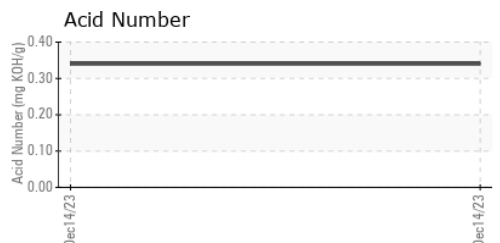
## GRAPHS

All component wear rates are normal.

There is no indication of any contamination in the oil.

The AN level is acceptable for this fluid. The condition of the oil is suitable for further service.

Little or no information is provided as to the component and lubricant being tested. Recommendations are therefore generic in nature and may not apply to the current application. Please forward information as to equipment type, reservoir capacity, lubricant type and any pertinent information to allow for a more accurate assessment. Resample at the next service interval to monitor. The fluid was not specified, however, a fluid match indicates that this fluid is ISO 32 AW Hydraulic Oil. Please confirm the oil type and grade, and specify the brand of the oil on your next sample. Please provide more complete information on your next sample. NOTE: Please provide information regarding reservoir capacity, filter type and micron rating with next sample.
