OIL ANALYSIS REPORT

Machine Id
CATERPILLAR 740GL HDTR0836
 Component
Front Left Final Drive
 Fluid
MOBIL 56 (--- GAL)

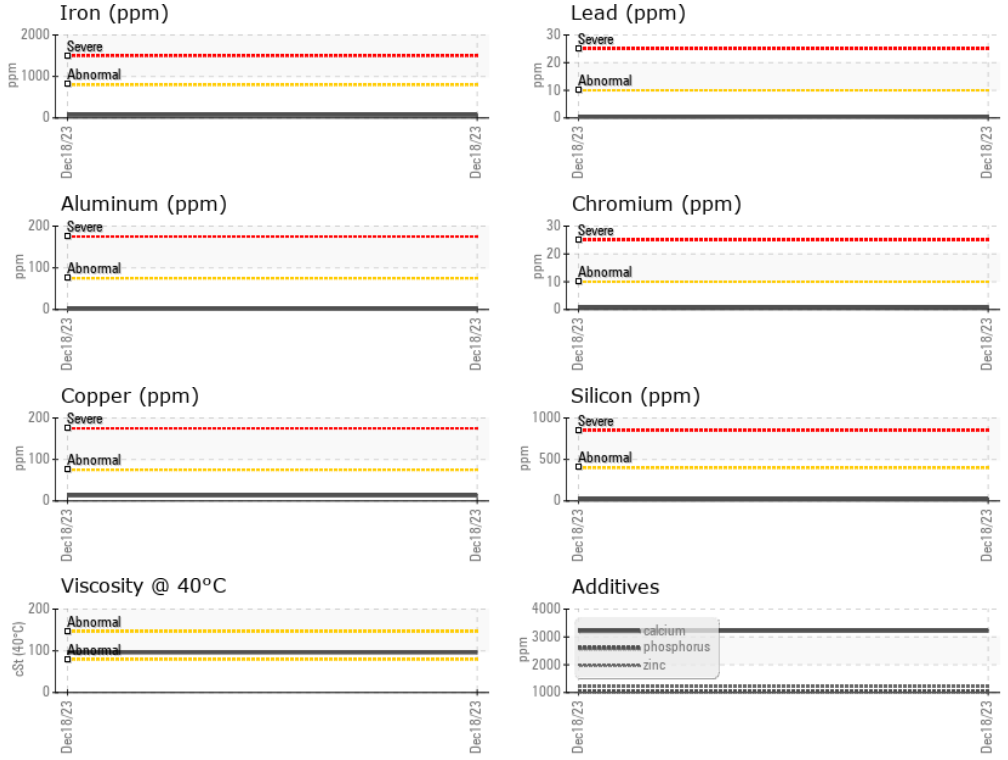
GRAPHS

All component wear rates are normal.

There is no indication of any contamination in the oil.

The condition of the oil is acceptable for the time in service.

Resample at the next service interval to monitor.
