OIL ANALYSIS REPORT

Machine Id
EPIROC ST18 SCP202

Component
Front Right Planetary

Fluid
PENNZOIL SYNTHETIC SAE 75W140 GL-5 (--- GAL)

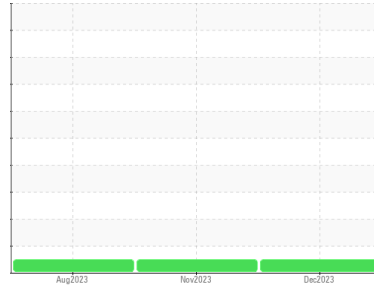
Sample Rating Trend

NORMAL

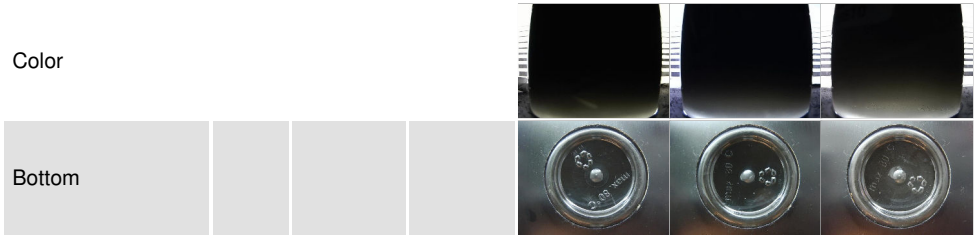
SAMPLE IMAGES	method	limit/base	current	history1	history2
---------------	--------	------------	---------	----------	----------

VISUAL	method	limit/base	current	history1	history2
White Metal	scalar	Visual*	NONE	NONE	VLITE
Yellow Metal	scalar	Visual*	NONE	NONE	NONE
Precipitate	scalar	Visual*	NONE	NONE	NONE
Silt	scalar	Visual*	NONE	VLITE	VLITE
Debris	scalar	Visual*	NONE	NONE	NONE
Sand/Dirt	scalar	Visual*	NONE	VLITE	NONE
Appearance	scalar	Visual*	NORML	NORML	NORML
Odor	scalar	Visual*	NORML	NORML	NORML
Emulsified Water	scalar	Visual*	>0.2	NEG	NEG
Free Water	scalar	Visual*		NEG	NEG

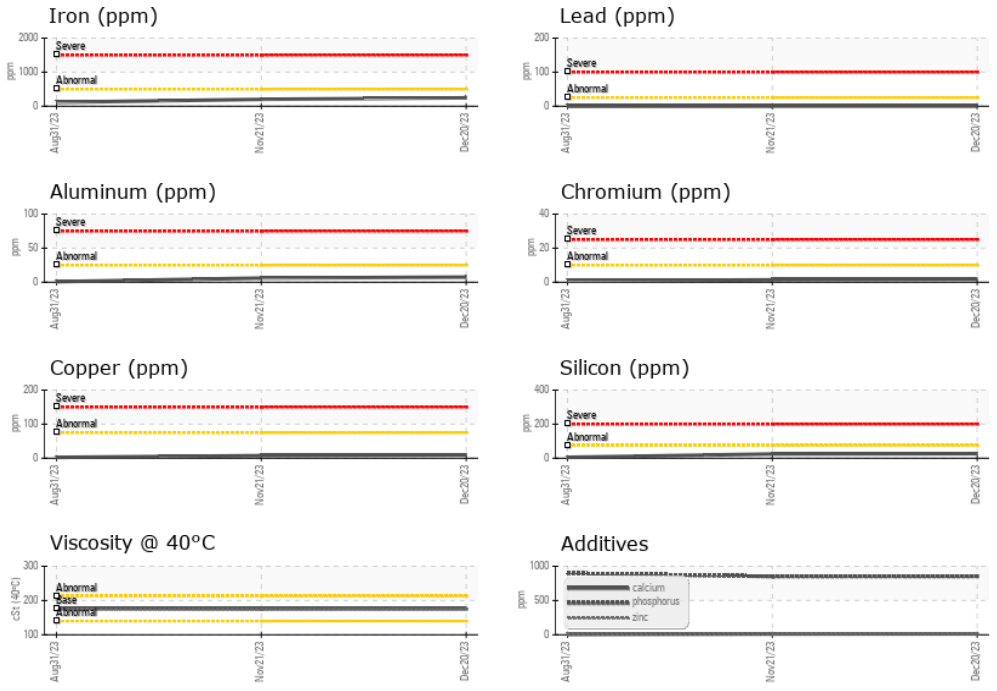
GRAPHS

All component wear rates are normal.

There is no indication of any contamination in the oil.

The condition of the oil is acceptable for the time in service.

Resample at the next service interval to monitor.
