# OIL ANALYSIS REPORT

Area  
**SAB2**  
 Machine Id  
**SAB2 G11 Governor**  
 Component  
**Hydraulic System**  
 Fluid  
**ESSO TERESSO ISO 46 (6160 LTR)**

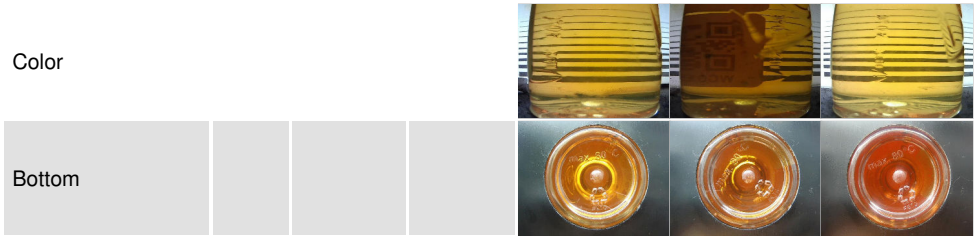
### SAMPLE IMAGES

The system cleanliness is acceptable for your target ISO 4406 cleanliness code. The system and fluid cleanliness is acceptable.

The AN level is acceptable for this fluid. The condition of the oil is suitable for further service.

Resample at the next service interval to monitor. Please contact your representative for information regarding the proper sampling kits for your service. NOTE: We recommend using IND 3 test kits, this testkit includes Analytical Ferrography which provides a detailed morphological analysis of wear particles present in the fluid.
