OIL ANALYSIS REPORT

Area
4 Calender Line
 Machine Id
38-0085 Feedmill
 Component
Gearbox
 Fluid
SUNOCO SUNE320 (180 GAL)

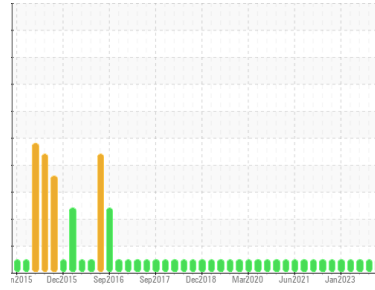
Sample Rating Trend

NORMAL

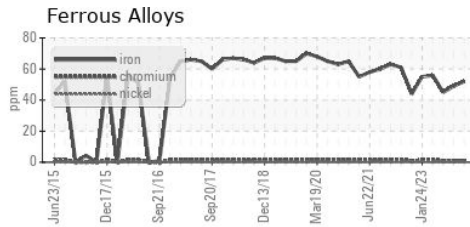
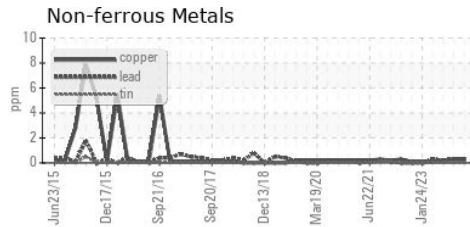
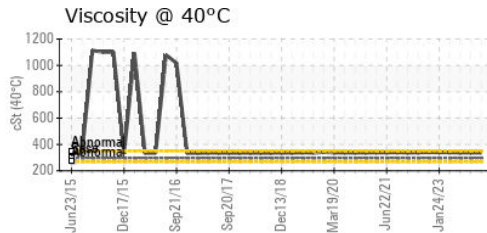
GRAPHS

All component wear rates are normal.

There is no indication of any contamination in the oil.

The condition of the oil is acceptable for the time in service.

Resample at the next service interval to monitor.
