CLEANLINESS TEST REPORT

Part Number
AT441512
Component
Hose Assembly
Fluid
KEROSENE (--- mL)

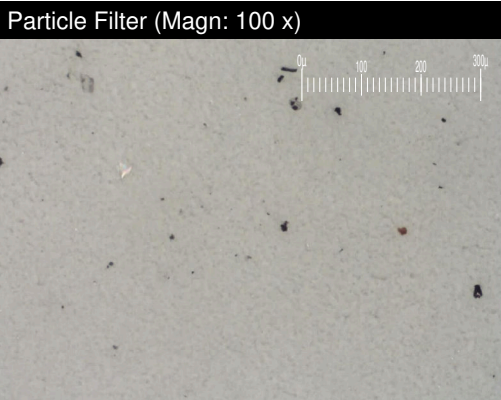
SAMPLE IMAGES		method	limit/base	current	history1	history2
Color					no image	no image
Bottom					no image	no image
PrtFilter					no image	no image

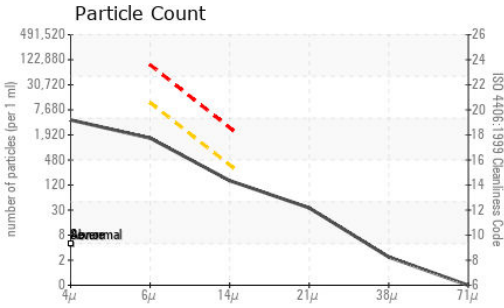
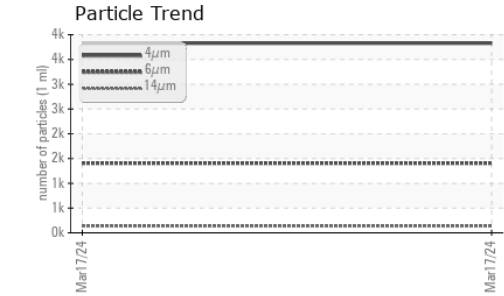
GRAPHS

FLUID CLEANLINESS		method	limit/base	current	history1	history2
Particles >4µm	ASTM D7647			3828	---	---
Particles >6µm	ASTM D7647	>10000		1406	---	---
Particles >14µm	ASTM D7647	>320		135	---	---
Particles >21µm	ASTM D7647	>80		30	---	---
Particles >38µm	ASTM D7647	>20		2	---	---
Particles >71µm	ASTM D7647	>4		0	---	---
Oil Cleanliness	ISO 4406 (c)	>--/20/15		19/18/14	---	---
