OIL ANALYSIS REPORT

Machine Id
CATERPILLAR R1600 SCP219
 Component
Rear Left Planetary
 Fluid
PETRO CANADA PRODURO TO-4 SAE 50 (--- GAL)

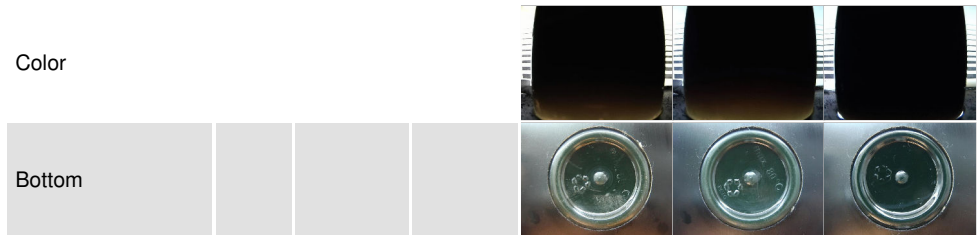
SAMPLE IMAGES	method	limit/base	current	history1	history2
---------------	--------	------------	---------	----------	----------

VISUAL	method	limit/base	current	history1	history2
White Metal	scalar	Visual*	NONE	NONE	NONE
Yellow Metal	scalar	Visual*	NONE	NONE	NONE
Precipitate	scalar	Visual*	NONE	NONE	NONE
Silt	scalar	Visual*	NONE	NONE	NONE
Debris	scalar	Visual*	NONE	NONE	NONE
Sand/Dirt	scalar	Visual*	NONE	NONE	NONE
Appearance	scalar	Visual*	NORML	NORML	NORML
Odor	scalar	Visual*	NORML	NORML	NORML
Emulsified Water	scalar	Visual*	>0.2	NEG	NEG
Free Water	scalar	Visual*		NEG	NEG

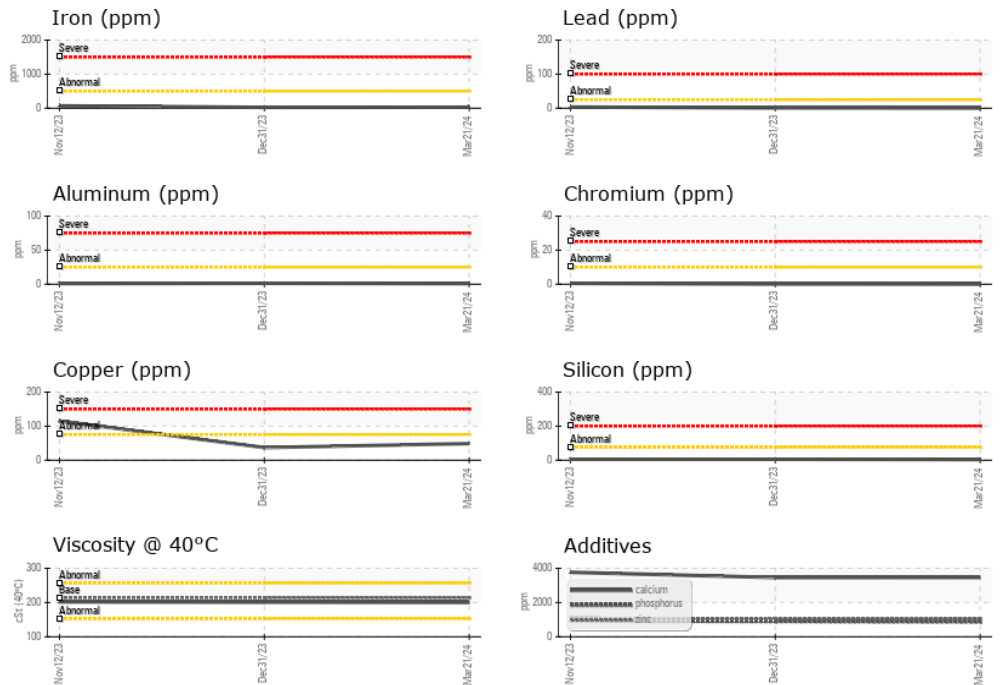
GRAPHS

All component wear rates are normal.

method	limit/base	current	history1	history2	
Iron	ppm	ASTM D5185(m)	>500	29	25	70
Chromium	ppm	ASTM D5185(m)	>10	0	<1	<1
Nickel	ppm	ASTM D5185(m)	>10	0	0	<1
Titanium	ppm	ASTM D5185(m)		0	0	0
Silver	ppm	ASTM D5185(m)		0	0	<1
Aluminum	ppm	ASTM D5185(m)	>25	<1	1	1
Lead	ppm	ASTM D5185(m)	>25	<1	1	3
Copper	ppm	ASTM D5185(m)	>75	49	37	115
Tin	ppm	ASTM D5185(m)	>10	1	1	4
Antimony	ppm	ASTM D5185(m)	>5	0	0	0
Vanadium	ppm	ASTM D5185(m)		0	0	0
Beryllium	ppm	ASTM D5185(m)		0	0	0
Cadmium	ppm	ASTM D5185(m)		0	0	0

Resample at the next service interval to monitor.
