OIL ANALYSIS REPORT

Area
SAB2
Machine Id
SAB2 G13
Component
Thrust Bearing
Fluid
ESSO TERESSO ISO 46 (3182 LTR)

Ontario Power Generation
 NIAGARA PLANT GROUP, 14000 NIAGARA PKWY
 NIAGARA ON THE LAKE, ON
 CA L0S 1J0
 Contact: Alex Courtemanche
 alex.courtemanche@opg.com
 T: (905)357-0322
 F: (905)357-6558

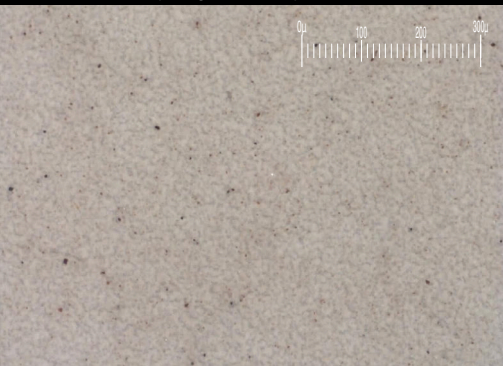
Particle Filter (Magn: 100 x)

There is a moderate amount of silt (particulates < 14 microns in size) present in the oil. The system cleanliness is above the acceptable limit for the target ISO 4406 cleanliness code.

We recommend you service the filters on this component. We recommend an early resample to monitor this condition. Please contact your representative for information regarding the proper sampling kits for your service. NOTE: We recommend using IND 3 test kits, this testkit includes Analytical Ferrography which provides a detailed morphological analysis of wear particles present in the fluid.

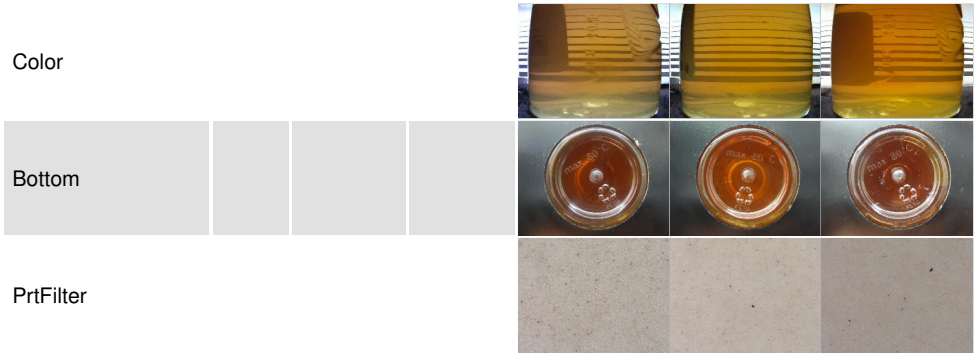
SAMPLE IMAGES	method	limit/base	current	history1	history2
---------------	--------	------------	---------	----------	----------

VISUAL	method	limit/base	current	history1	history2	
White Metal	scalar	Visual*	NONE	NONE	NONE	NONE
Yellow Metal	scalar	Visual*	NONE	NONE	NONE	NONE
Precipitate	scalar	Visual*	NONE	NONE	NONE	NONE
Silt	scalar	Visual*	NONE	NONE	NONE	NONE
Debris	scalar	Visual*	NONE	NONE	NONE	NONE
Sand/Dirt	scalar	Visual*	NONE	NONE	NONE	NONE
Appearance	scalar	Visual*	NORML	NORML	NORML	NORML
Odor	scalar	Visual*	NORML	NORML	NORML	NORML
Emulsified Water	scalar	Visual*	>2	NEG	NEG	NEG
Free Water	scalar	Visual*		NEG	NEG	NEG
