OIL ANALYSIS REPORT

Machine Id
JOHN DEERE 744P LDR016

Component
Rear Differential

Fluid
JOHN DEERE HY-GARD HYD/TRANS (--- GAL)

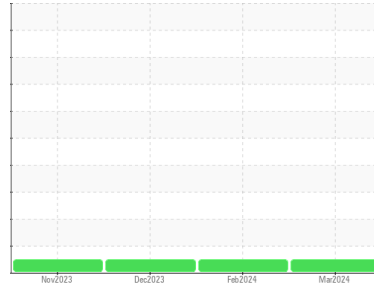
NORMAL

All component wear rates are normal.

There is no indication of any contamination in the oil.

The condition of the oil is acceptable for the time in service.

Resample at the next service interval to monitor.

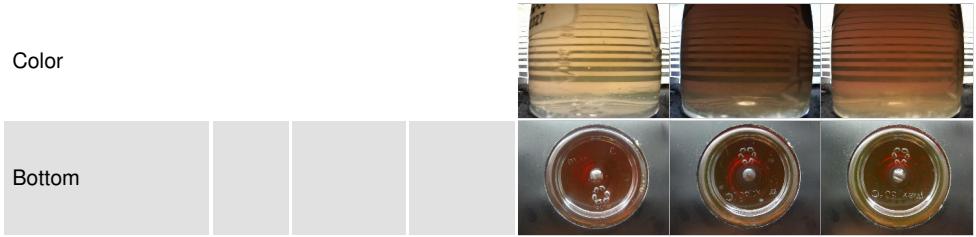
SAMPLE IMAGES	method	limit/base	current	history1	history2
---------------	--------	------------	---------	----------	----------

VISUAL	method	limit/base	current	history1	history2
White Metal	scalar	Visual*	NONE	NONE	NONE
Yellow Metal	scalar	Visual*	NONE	NONE	NONE
Precipitate	scalar	Visual*	NONE	NONE	NONE
Silt	scalar	Visual*	NONE	NONE	NONE
Debris	scalar	Visual*	NONE	NONE	NONE
Sand/Dirt	scalar	Visual*	NONE	NONE	NONE
Appearance	scalar	Visual*	NORML	NORML	NORML
Odor	scalar	Visual*	NORML	NORML	NORML
Emulsified Water	scalar	Visual*	>.2	NEG	NEG
Free Water	scalar	Visual*		NEG	NEG
