# OIL ANALYSIS REPORT

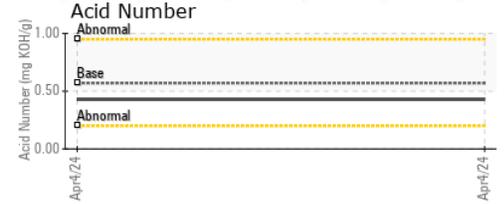
### GRAPHS

FLUID DEGRADATION	method	limit/base	current	history1	history2	
Acid Number (AN)	mg KOH/g	ASTM D974*	0.57	<b>0.43</b>	---	---

FLUID PROPERTIES	method	limit/base	current	history1	history2	
Visc @ 40°C	cSt	ASTM D7279(m)	46	<b>45.5</b>	---	---
