OIL ANALYSIS REPORT

Machine Id
JOHN DEERE 644K LDR009
 Component
Front Differential
 Fluid
ESSO HYDRAUL 56 (--- GAL)

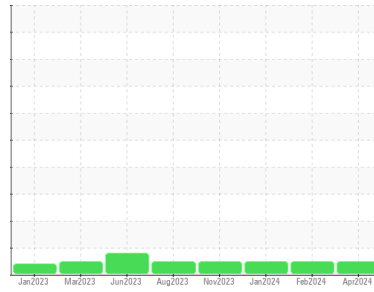
Sample Rating Trend

NORMAL

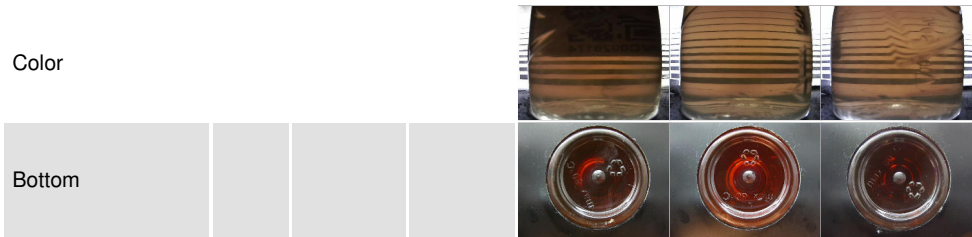
SAMPLE IMAGES	method	limit/base	current	history1	history2
---------------	--------	------------	---------	----------	----------

VISUAL	method	limit/base	current	history1	history2
White Metal	scalar	Visual*	NONE	NONE	NONE
Yellow Metal	scalar	Visual*	NONE	NONE	NONE
Precipitate	scalar	Visual*	NONE	NONE	NONE
Silt	scalar	Visual*	NONE	NONE	NONE
Debris	scalar	Visual*	NONE	NONE	NONE
Sand/Dirt	scalar	Visual*	NONE	NONE	NONE
Appearance	scalar	Visual*	NORML	NORML	NORML
Odor	scalar	Visual*	NORML	NORML	NORML
Emulsified Water	scalar	Visual*	>.2	NEG	NEG
Free Water	scalar	Visual*		NEG	NEG
