# OIL ANALYSIS REPORT

# FERROGRAPHY REPORT

Area  
**(C-FHPB)**  
 Machine Id  
**[C-FHPB] BEECHCRAFT B300 KING AIR PCE-95426**  
 Component  
**Left Jet Turbine**  
 Fluid  
**EASTMAN TURBO OIL 2380 (12 QTS)**

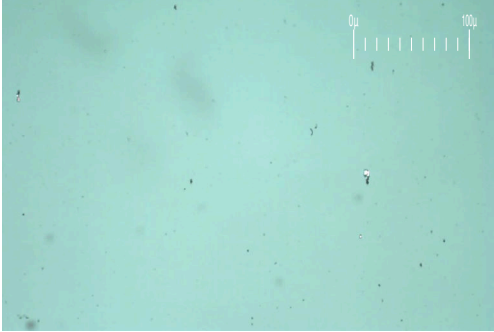
Magn: 200x Illum: BC

Wear particle analysis indicates that the ferrous cutting particles are abnormal. Cutting wear particles are caused by either hard protuberances (mis-aligned components, etc.), or abrasives entering the system and embedding themselves in softer materials (sand, etc.), and gouging out mating surfaces.
