Machine Id
CDM44580

Component
Gearbox

Fluid
KLUBER CLP-PG 460 (--- GAL)

OIL ANALYSIS REPORT

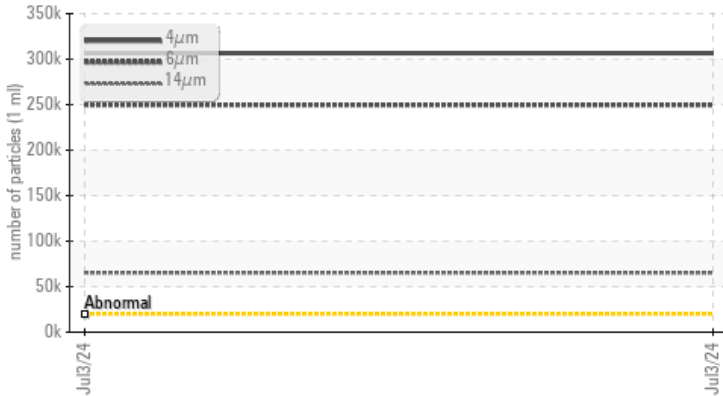
▲ Particle Trend

Sample Status			SEVERE	---	---
Particles >4µm	ASTM D7647	>20000	▲ 306513	---	---
Particles >6µm	ASTM D7647	>5000	▲ 249665	---	---
Particles >14µm	ASTM D7647	>640	▲ 65229	---	---
Particles >21µm	ASTM D7647	>160	▲ 10897	---	---
Oil Cleanliness	ISO 4406 (c)	>21/19/16	▲ 25/25/23	---	---

There is a high amount of particulates (2 to 100 microns in size) present in the oil.

We advise that you check all areas where contaminants can enter the system. We advise that you perform a filter service, and use off-line filtration to improve the cleanliness of the system fluid. The air breather requires service. If unrated, we recommend that you replace with a suitable micron rated and/or desiccant air breather. If rated, we recommend that you service/replace the breather. Resample in 30-45 days to monitor this situation. NOTE: Please provide information regarding reservoir capacity, filter type and micron rating with next sample.
