# OIL ANALYSIS REPORT

Area  
**[539414]**  
 Machine Id  
**2022311**  
 Component  
**Unknown Component**  
 Fluid  
**{not provided} (--- GAL)**

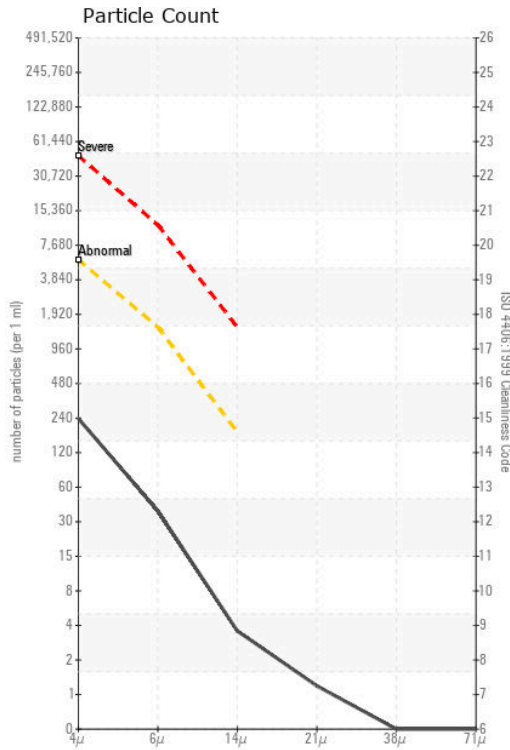
## GRAPHS

ISO Cleanliness Code (ISO 4406:1999): 15/12/9;  
 Cumulative particle counts >4µm = 209, >6µm = 33,  
 >14µm = 3, >21µm = 1, >38µm = 0, >71µm = 0.

This is a baseline read-out on the submitted sample.
