# PROBLEM SUMMARY

Machine Id  
**NO UNIT WC0941996**  
 Component  
**Hydraulic System**  
 Fluid  
**TDH FLUID SAE 75W80 (--- GAL)**

# OIL ANALYSIS REPORT

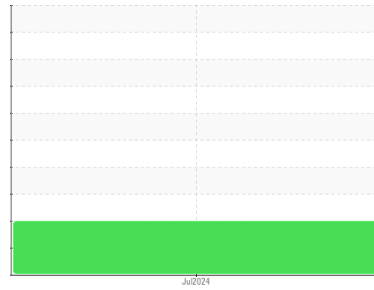
## Sample Rating Trend

Sample Status			SEVERE	---	---
Particles >4µm	ASTM D7647	>5000	▲ 79441	---	---
Particles >6µm	ASTM D7647	>1300	▲ 3582	---	---
Oil Cleanliness	ISO 4406 (c)	>19/17/14	▲ 23/19/10	---	---

Action	Status	Date	Done By	Description
Change Filter	---	---	?	We recommend you service the filters on this component.
Resample	---	---	?	Resample in 30-45 days to monitor this situation.
Alert	---	---	?	Vu la faible quantité d'informations pour cet équipement et son lubrifiant, les recommandations sont d'ordre général et peuvent ne pas s'appliquer à cette application. Veuillez nous transmettre les informations sur l'équipement, la contenance du réservoir, le type de lubrifiant et toute autre information pertinente pour une évaluation plus précise.
Information Required	---	---	?	À NOTER: S.V.P. inclure, avec le prochain échantillon, des détails de la capacité du réservoir et le type et le degré de filtration.
Check Breathers	---	---	?	The air breather requires service. If unrated, we recommend that you replace with a suitable micron rated and/or desiccant air breather. If rated, we recommend that you service/replace the breather.

Check Seals	---	---	?	Check seals and/or filters for points of contaminant entry.

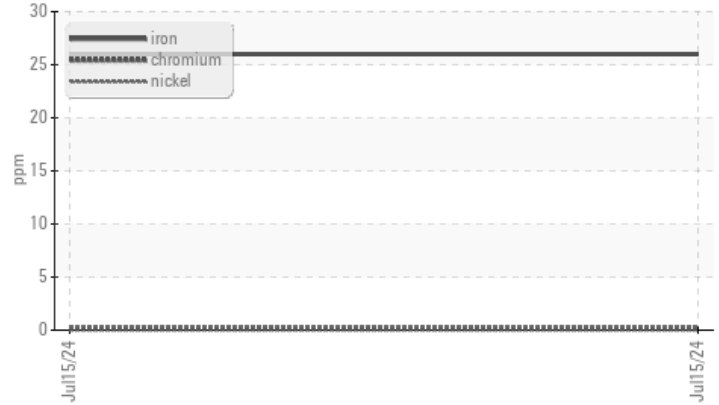
### Ferrous Alloys

Les taux d'usure de tous les composants sont normaux.
