# PROBLEM SUMMARY

# OIL ANALYSIS REPORT

Machine Id  
**PALFINGER 100490425**  
 Component  
**Hydraulic System**  
 Fluid  
**AW HYDRAULIC OIL ISO 32 (--- GAL)**

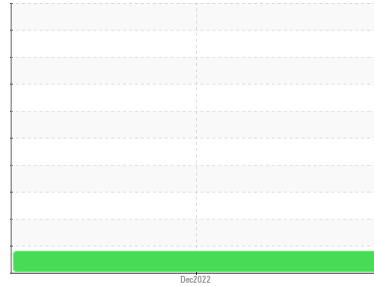
Sample Rating Trend

### ▲ Particle Trend

Sample Status			<b>ABNORMAL</b>	---	---
Particles >4µm	ASTM D7647	>5000	▲ <b>11963</b>	---	---
Oil Cleanliness	ISO 4406 (c)	>19/17/14	▲ <b>21/16/11</b>	---	---

No corrective action is recommended at this time.  
 Resample at the next service interval to monitor.

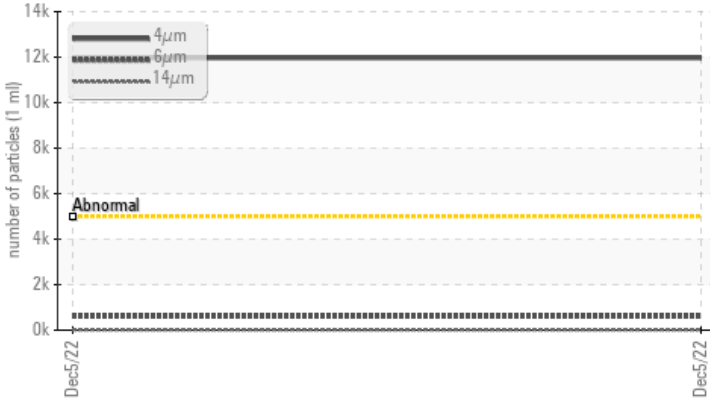
There is a high amount of silt (particulates < 14 microns in size) present in the oil.

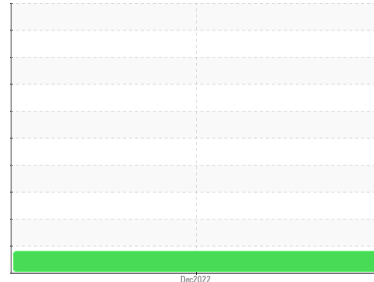
Sample Rating Trend

All component wear rates are normal.

The AN level is acceptable for this fluid. The condition of the oil is suitable for further service.

No corrective action is recommended at this time. Resample at the next service interval to monitor.
