PROBLEM SUMMARY

Area
IRON STAR [200006142]
 Machine Id
27WEA88338
 Component
Wind Turbine Gearbox
 Fluid
GEAR OIL (PAO) ISO 320 (--- LTR)

OIL ANALYSIS REPORT

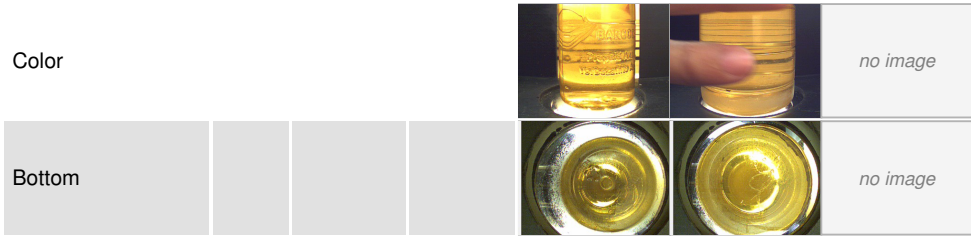
SAMPLE IMAGES	method	limit/base	current	history1	history2
---------------	--------	------------	---------	----------	----------

VISUAL	method	limit/base	current	history1	history2
White Metal	scalar	*Visual	NONE	NONE	---
Yellow Metal	scalar	*Visual	NONE	NONE	---
Precipitate	scalar	*Visual	NONE	NONE	---
Silt	scalar	*Visual	NONE	NONE	---
Debris	scalar	*Visual	NONE	NONE	---
Sand/Dirt	scalar	*Visual	NONE	NONE	---
Appearance	scalar	*Visual	NORML	NORML	---
Odor	scalar	*Visual	NORML	NORML	---
Emulsified Water	scalar	*Visual	>0.02	NEG	---
Free Water	scalar	*Visual		NEG	---
