PROBLEM SUMMARY

Area
IRON STAR [200006142]
 Machine Id
62WEA88300
 Component
Wind Turbine Gearbox
 Fluid
GEAR OIL (PAO) ISO 320 (--- LTR)

OIL ANALYSIS REPORT

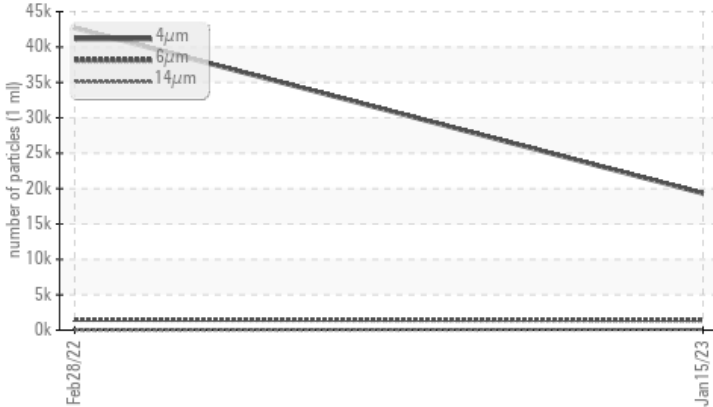
▲ Particle Trend

Sample Status			ATTENTION	ABNORMAL	---
Particles >6µm	ASTM D7647	>1300	▲ 1450	▲ 1494	---
Oil Cleanliness	ISO 4406 (c)	>17/14	▲ 18/14	▲ 23/18/12	---

There is a moderate amount of silt (particulates < 14 microns in size) present in the oil.

No corrective action is recommended at this time.
 Resample at the next service interval to monitor.

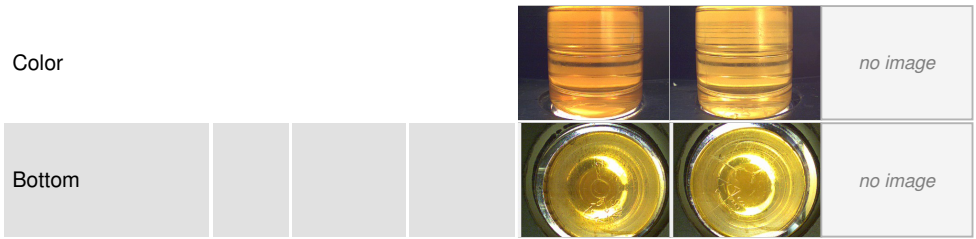
SAMPLE IMAGES	method	limit/base	current	history1	history2
---------------	--------	------------	---------	----------	----------

VISUAL	method	limit/base	current	history1	history2
White Metal	scalar	*Visual	NONE	NONE	---
Yellow Metal	scalar	*Visual	NONE	NONE	---
Precipitate	scalar	*Visual	NONE	NONE	---
Silt	scalar	*Visual	NONE	NONE	---
Debris	scalar	*Visual	NONE	NONE	---
Sand/Dirt	scalar	*Visual	NONE	NONE	---
Appearance	scalar	*Visual	NORML	NORML	---
Odor	scalar	*Visual	NORML	NORML	---
Emulsified Water	scalar	*Visual	>0.02	NEG	---
Free Water	scalar	*Visual		NEG	---
