PROBLEM SUMMARY

Area
IRON STAR [200006142]
 Machine Id
12WEA88292
 Component
Wind Turbine Gearbox
 Fluid
GEAR OIL (PAO) ISO 320 (--- LTR)

OIL ANALYSIS REPORT

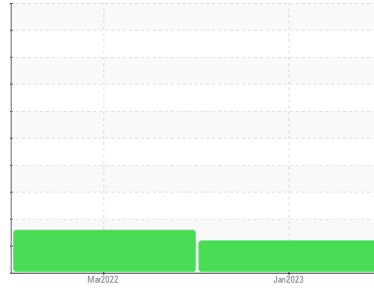
Sample Rating Trend

Sample Status			ABNORMAL	ABNORMAL	---
Particles >6µm	ASTM D7647	>320	▲ 791	▲ 1085	---
Particles >14µm	ASTM D7647	>40	▲ 41	▲ 72	---
Oil Cleanliness	ISO 4406 (c)	>--/15/12	▲ 22/17/13	▲ 22/17/13	---

We recommend you service the filters on this component if applicable. Resample at the next service interval to monitor.

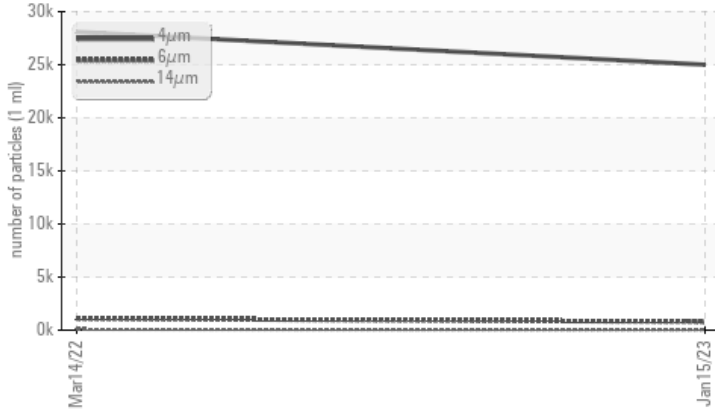
▲ Particle Trend

There is a high amount of particulates present in the oil.
