# PROBLEM SUMMARY

Machine Id  
**MOTIVA UNIT 12**

Component  
**Outboard Pump**

# OIL ANALYSIS REPORT

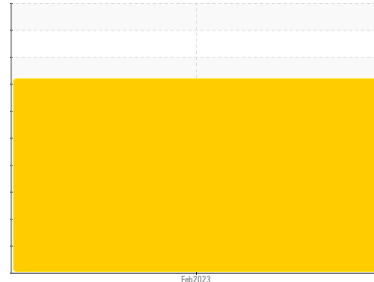
Sample Rating Trend

WEAR

Sample Status				SEVERE	---	---
Copper	ppm	ASTM D5185m	>30	84	---	---
White Metal	scalar	*Visual	NONE	MODER	---	---

We recommend you service the filters on this component. We advise that you inspect for the source(s) of wear. We recommend an early resample to monitor this condition.

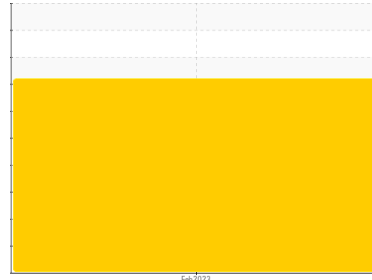
Sample Rating Trend

WEAR

Moderate concentration of visible metal present. Bearing and/or bushing wear is indicated.

We recommend you service the filters on this component. We advise that you inspect for the source(s) of wear. We recommend an early resample to monitor this condition.
