Machine Id
KMGP UNIT 1

Component
Inboard Pump

Fluid
ROYAL PURPLE SYNFILM GT 32 (--- GAL)

OIL ANALYSIS REPORT

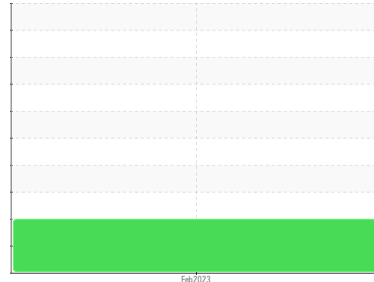
Sample Rating Trend

The lead level is abnormal. Moderate concentration of visible metal present. All other component wear rates are normal.

There is no indication of any contamination in the oil.

The AN level is acceptable for this fluid. The condition of the oil is acceptable for the time in service.

We recommend you service the filters on this component if applicable. Resample at the next service interval to monitor.
