# PROBLEM SUMMARY

Machine Id  
**PALFINGER 100458626**  
 Component  
**Hydraulic System**  
 Fluid  
**NOT GIVEN (--- GAL)**

# OIL ANALYSIS REPORT

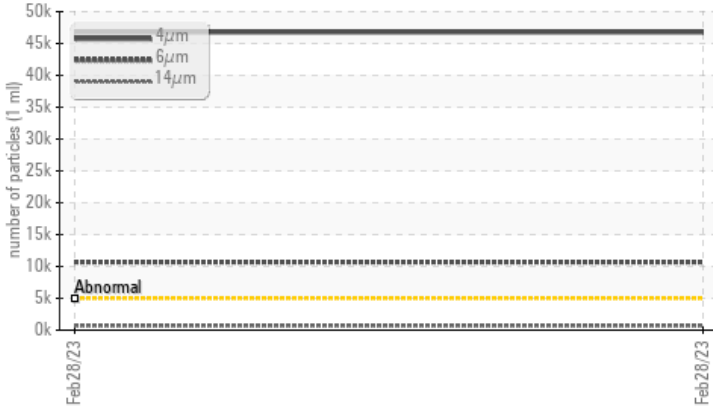
### ▲ Particle Trend

Sample Status			<b>ABNORMAL</b>	---	---
Particles >4µm	ASTM D7647	>5000	▲ <b>46776</b>	---	---
Particles >6µm	ASTM D7647	>1300	▲ <b>10676</b>	---	---
Particles >14µm	ASTM D7647	>160	▲ <b>684</b>	---	---
Particles >21µm	ASTM D7647	>40	▲ <b>112</b>	---	---
Oil Cleanliness	ISO 4406 (c)	>19/17/14	▲ <b>23/21/17</b>	---	---

There is a high amount of particulates present in the oil.

We recommend you service the filters on this component. Resample at the next service interval to monitor.
