Customer Id: PALJACNJ
Sample No.: WC0780267
Lab Number: 05822607
Test Package: CONST

OIL ANALYSIS REPORT

Machine Id
NOT GIVEN WC0780267
 Component
Hydraulic System
 Fluid
Hydraulic System Oil (--- GAL)

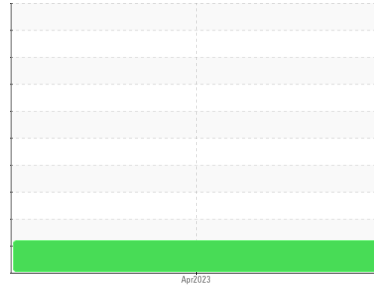
Sample Rating Trend

We recommend you service the filters on this component. Resample at the next service interval to monitor. We were unable to perform a particle count due to metal particles present in this sample.

Sample Status				ABNORMAL	---	---
White Metal	scalar	*Visual	NONE	▲ MODER	---	---

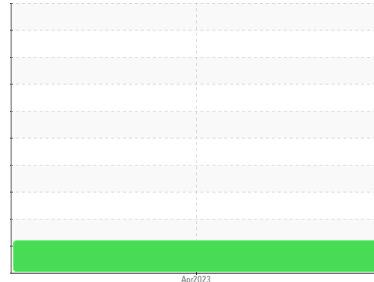
Sample Rating Trend

Moderate concentration of visible metal present. All component wear rates are normal.

We recommend you service the filters on this component. Resample at the next service interval to monitor. We were unable to perform a particle count due to metal particles present in this sample.
