Area
[185984-N2STV4W]
 Machine Id
245618
 Component
Hydraulic System
 Fluid
HLP 46 (40 GAL)

Customer Id: CONSAC
 Sample No.: PH05833857
 Lab Number: 05833857
 Test Package: PLANT

OIL ANALYSIS REPORT

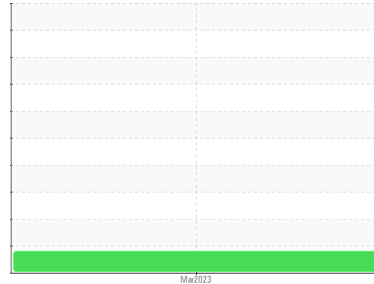
Sample Rating Trend

There is a moderate amount of silt (particulates < 14 microns in size) present in the oil.

method	limit/base	current	history1	history2
Particles >4µm	ASTM D7647	>2500	1643	---
Particles >6µm	ASTM D7647	>320	508	---
Particles >14µm	ASTM D7647	>40	25	---
Particles >21µm	ASTM D7647	>10	5	---
Particles >38µm	ASTM D7647	>3	0	---
Particles >71µm	ASTM D7647	>3	0	---
Oil Cleanliness	ISO 4406 (c)	>18/15/12	18/16/12	---

No corrective action is recommended at this time. Resample at the next service interval to monitor.
