OIL ANALYSIS REPORT

Area
CONNECTION BAY
 Machine Id
HBB SCRAP CHOPPER O/S
 Component
Gearbox
 Fluid
GEAR OIL ISO 320 (--- QTS)

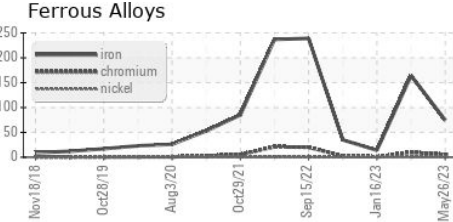
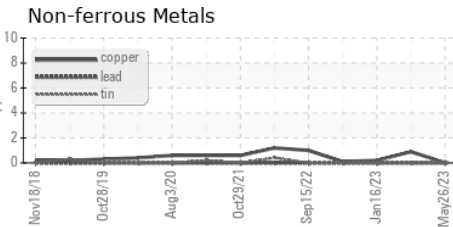
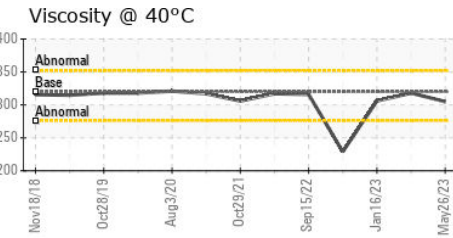
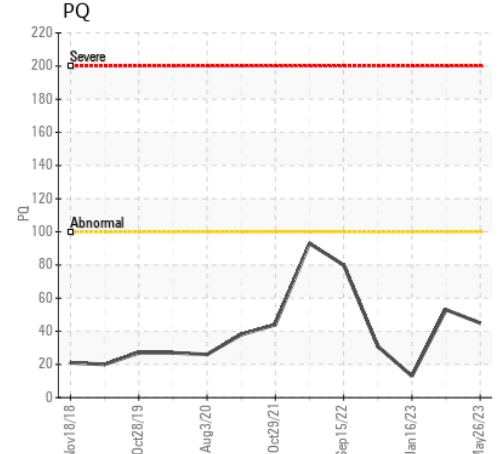
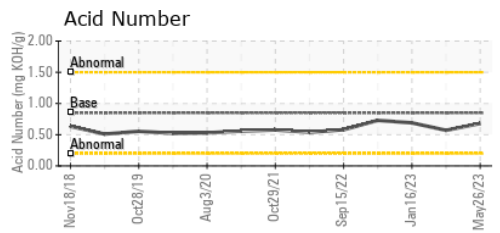
GRAPHS

method	limit/base	current	history1	history2
PQ	ASTM D8184		45	53	13
Iron	ppm	ASTM D5185m >200	75	▲ 164	14
Chromium	ppm	ASTM D5185m >15	5	10	<1
Nickel	ppm	ASTM D5185m >15	<1	1	0
Titanium	ppm	ASTM D5185m	<1	<1	0
Silver	ppm	ASTM D5185m	0	0	0
Aluminum	ppm	ASTM D5185m >25	0	1	0
Lead	ppm	ASTM D5185m >100	0	0	0
Copper	ppm	ASTM D5185m >200	0	<1	<1
Tin	ppm	ASTM D5185m >25	0	0	0
Vanadium	ppm	ASTM D5185m	0	0	0
Cadmium	ppm	ASTM D5185m	0	0	0

method	limit/base	current	history1	history2
Silicon	ppm	ASTM D5185m >50	6	30	4
Sodium	ppm	ASTM D5185m	<1	1	0
Potassium	ppm	ASTM D5185m >20	2	<1	<1
Water	%	ASTM D6304 >0.2	0.005	0.014	0.015
ppm Water	ppm	ASTM D6304 >2000	52.6	145.9	158.9

method	limit/base	current	history1	history2
Acid Number (AN)	mg KOH/g	ASTM D8045 0.85	0.68	0.57	0.69
